SETON COLLEGIATE CHURCH.

By STEWART CRUDEN, A.R.I.B.A., F.S.A., F.S.A.Scot.,  
Inspector of Ancient Monuments for Scotland.

This paper is primarily an account of work done by the Ministry of Works, and particularly a discussion of problems raised by that work.

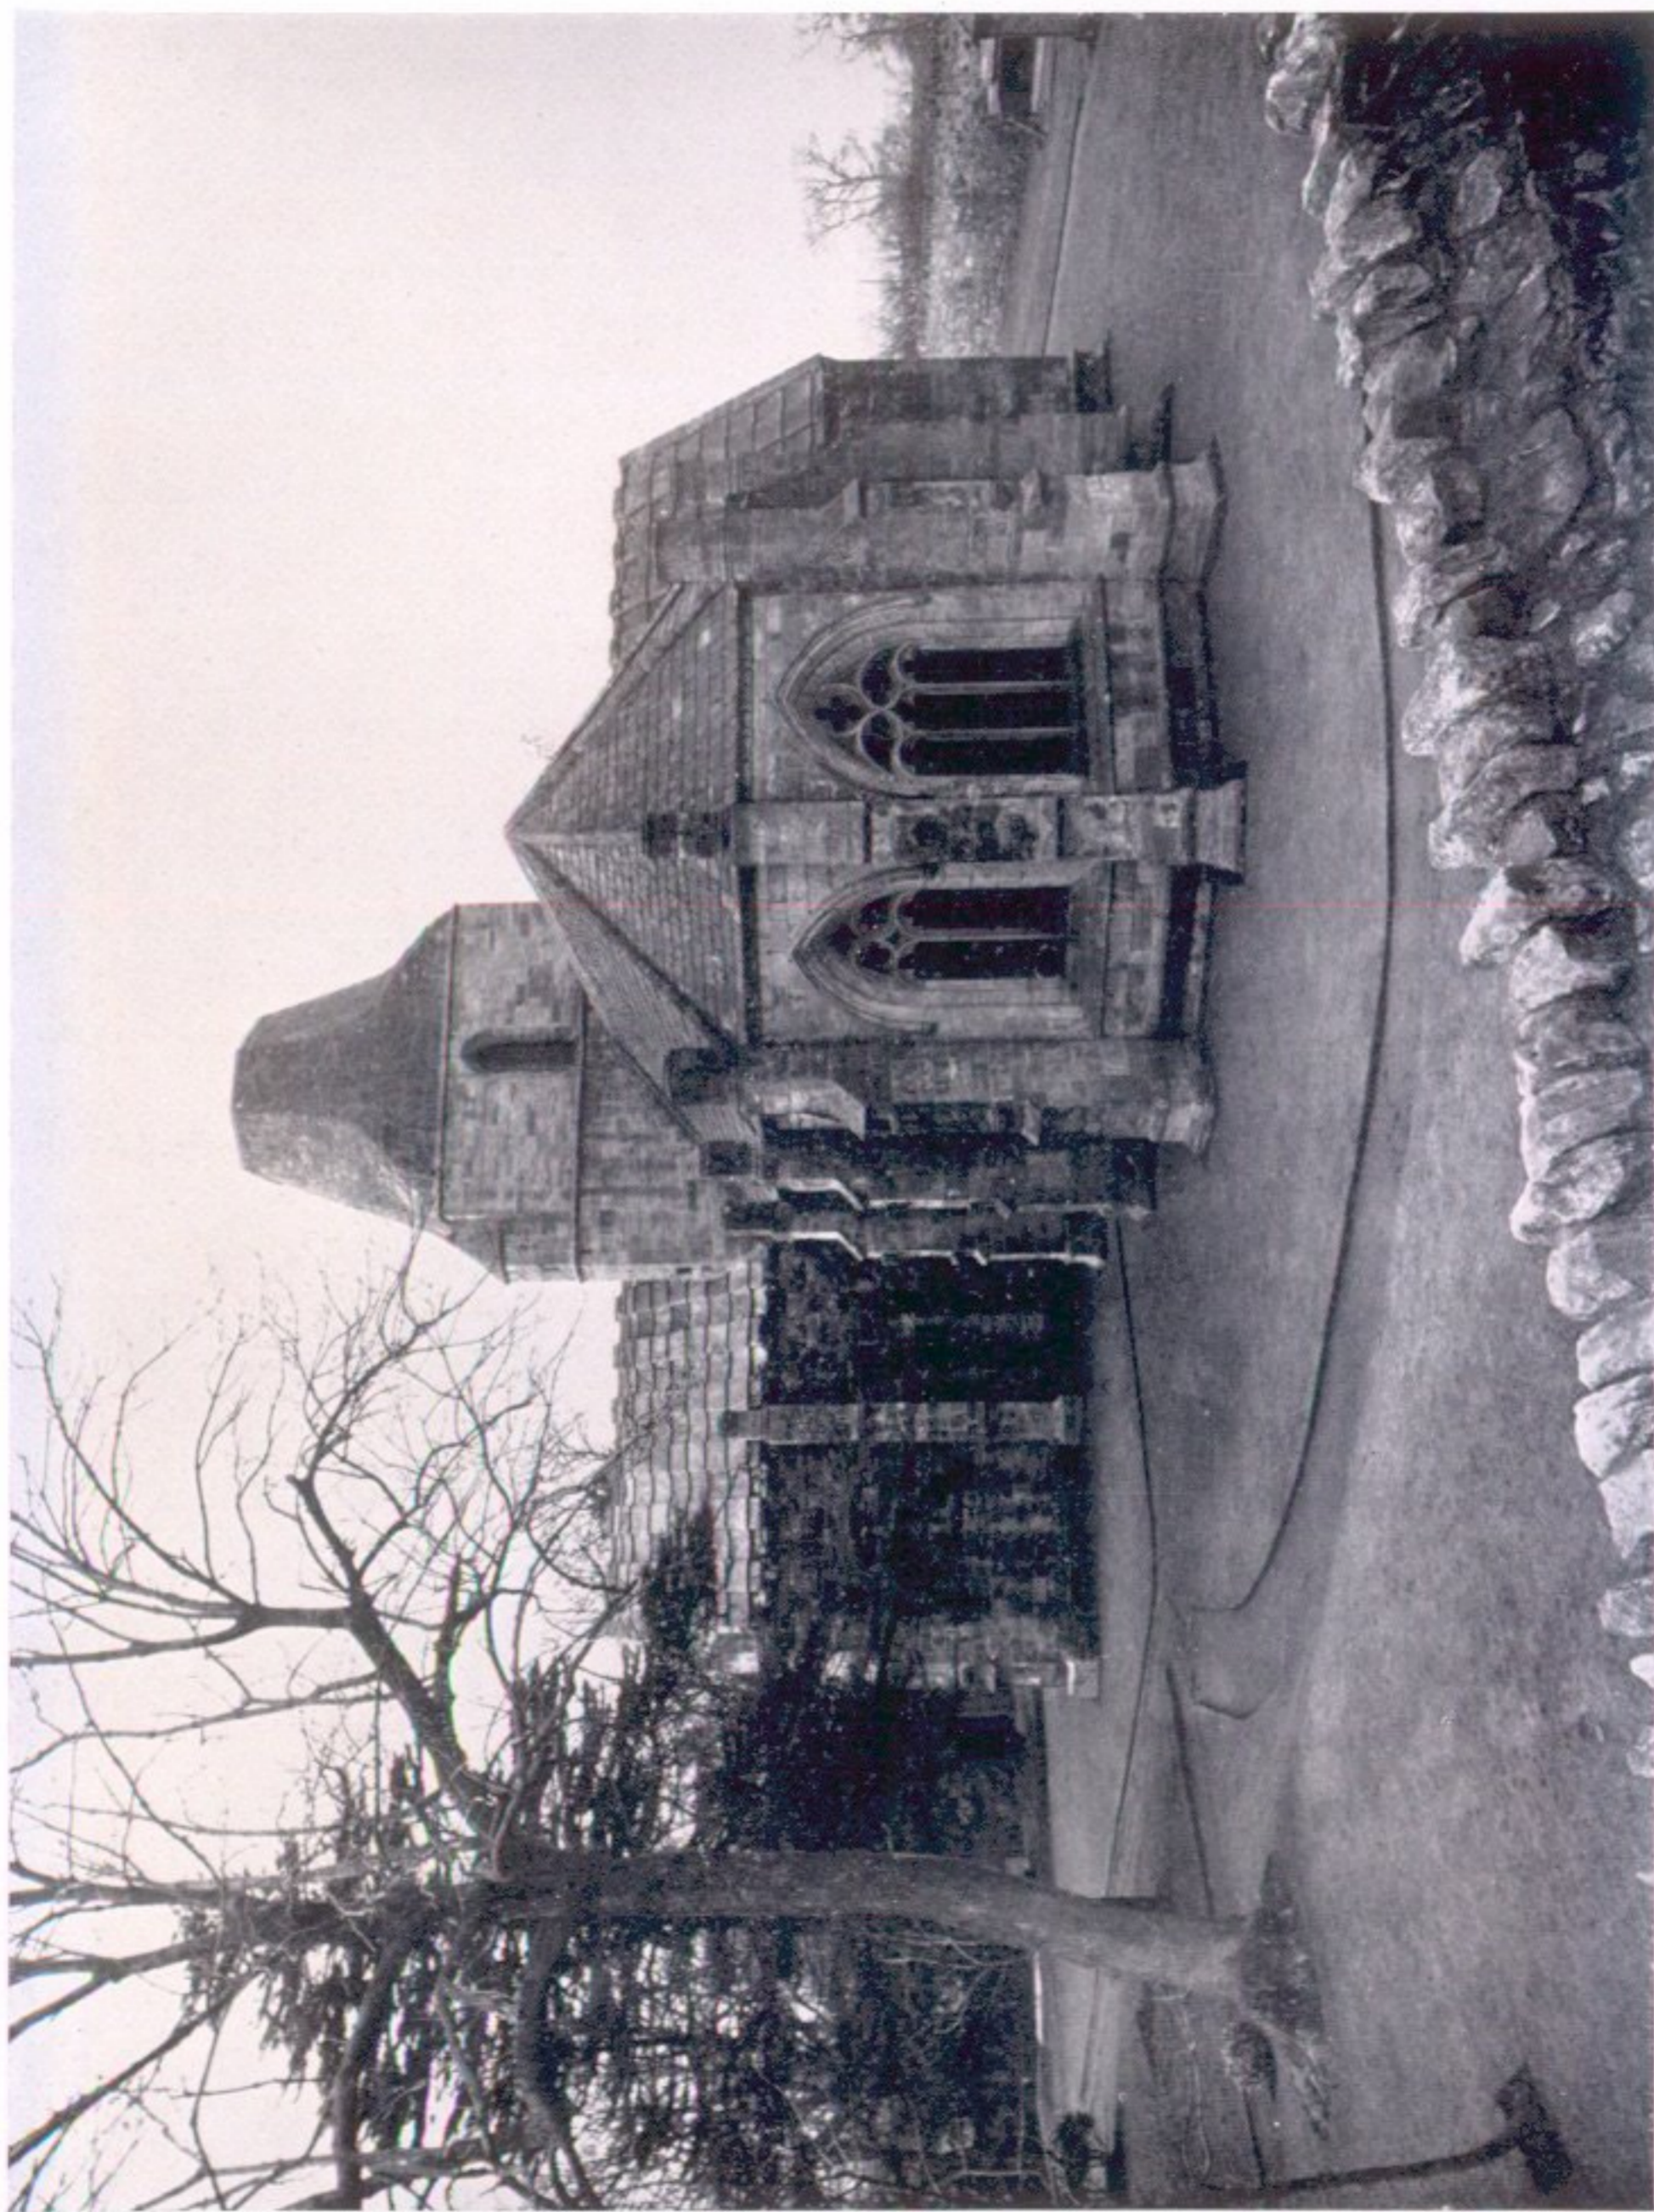
Seton Collegiate Church: east end, 1470-8; looking west.

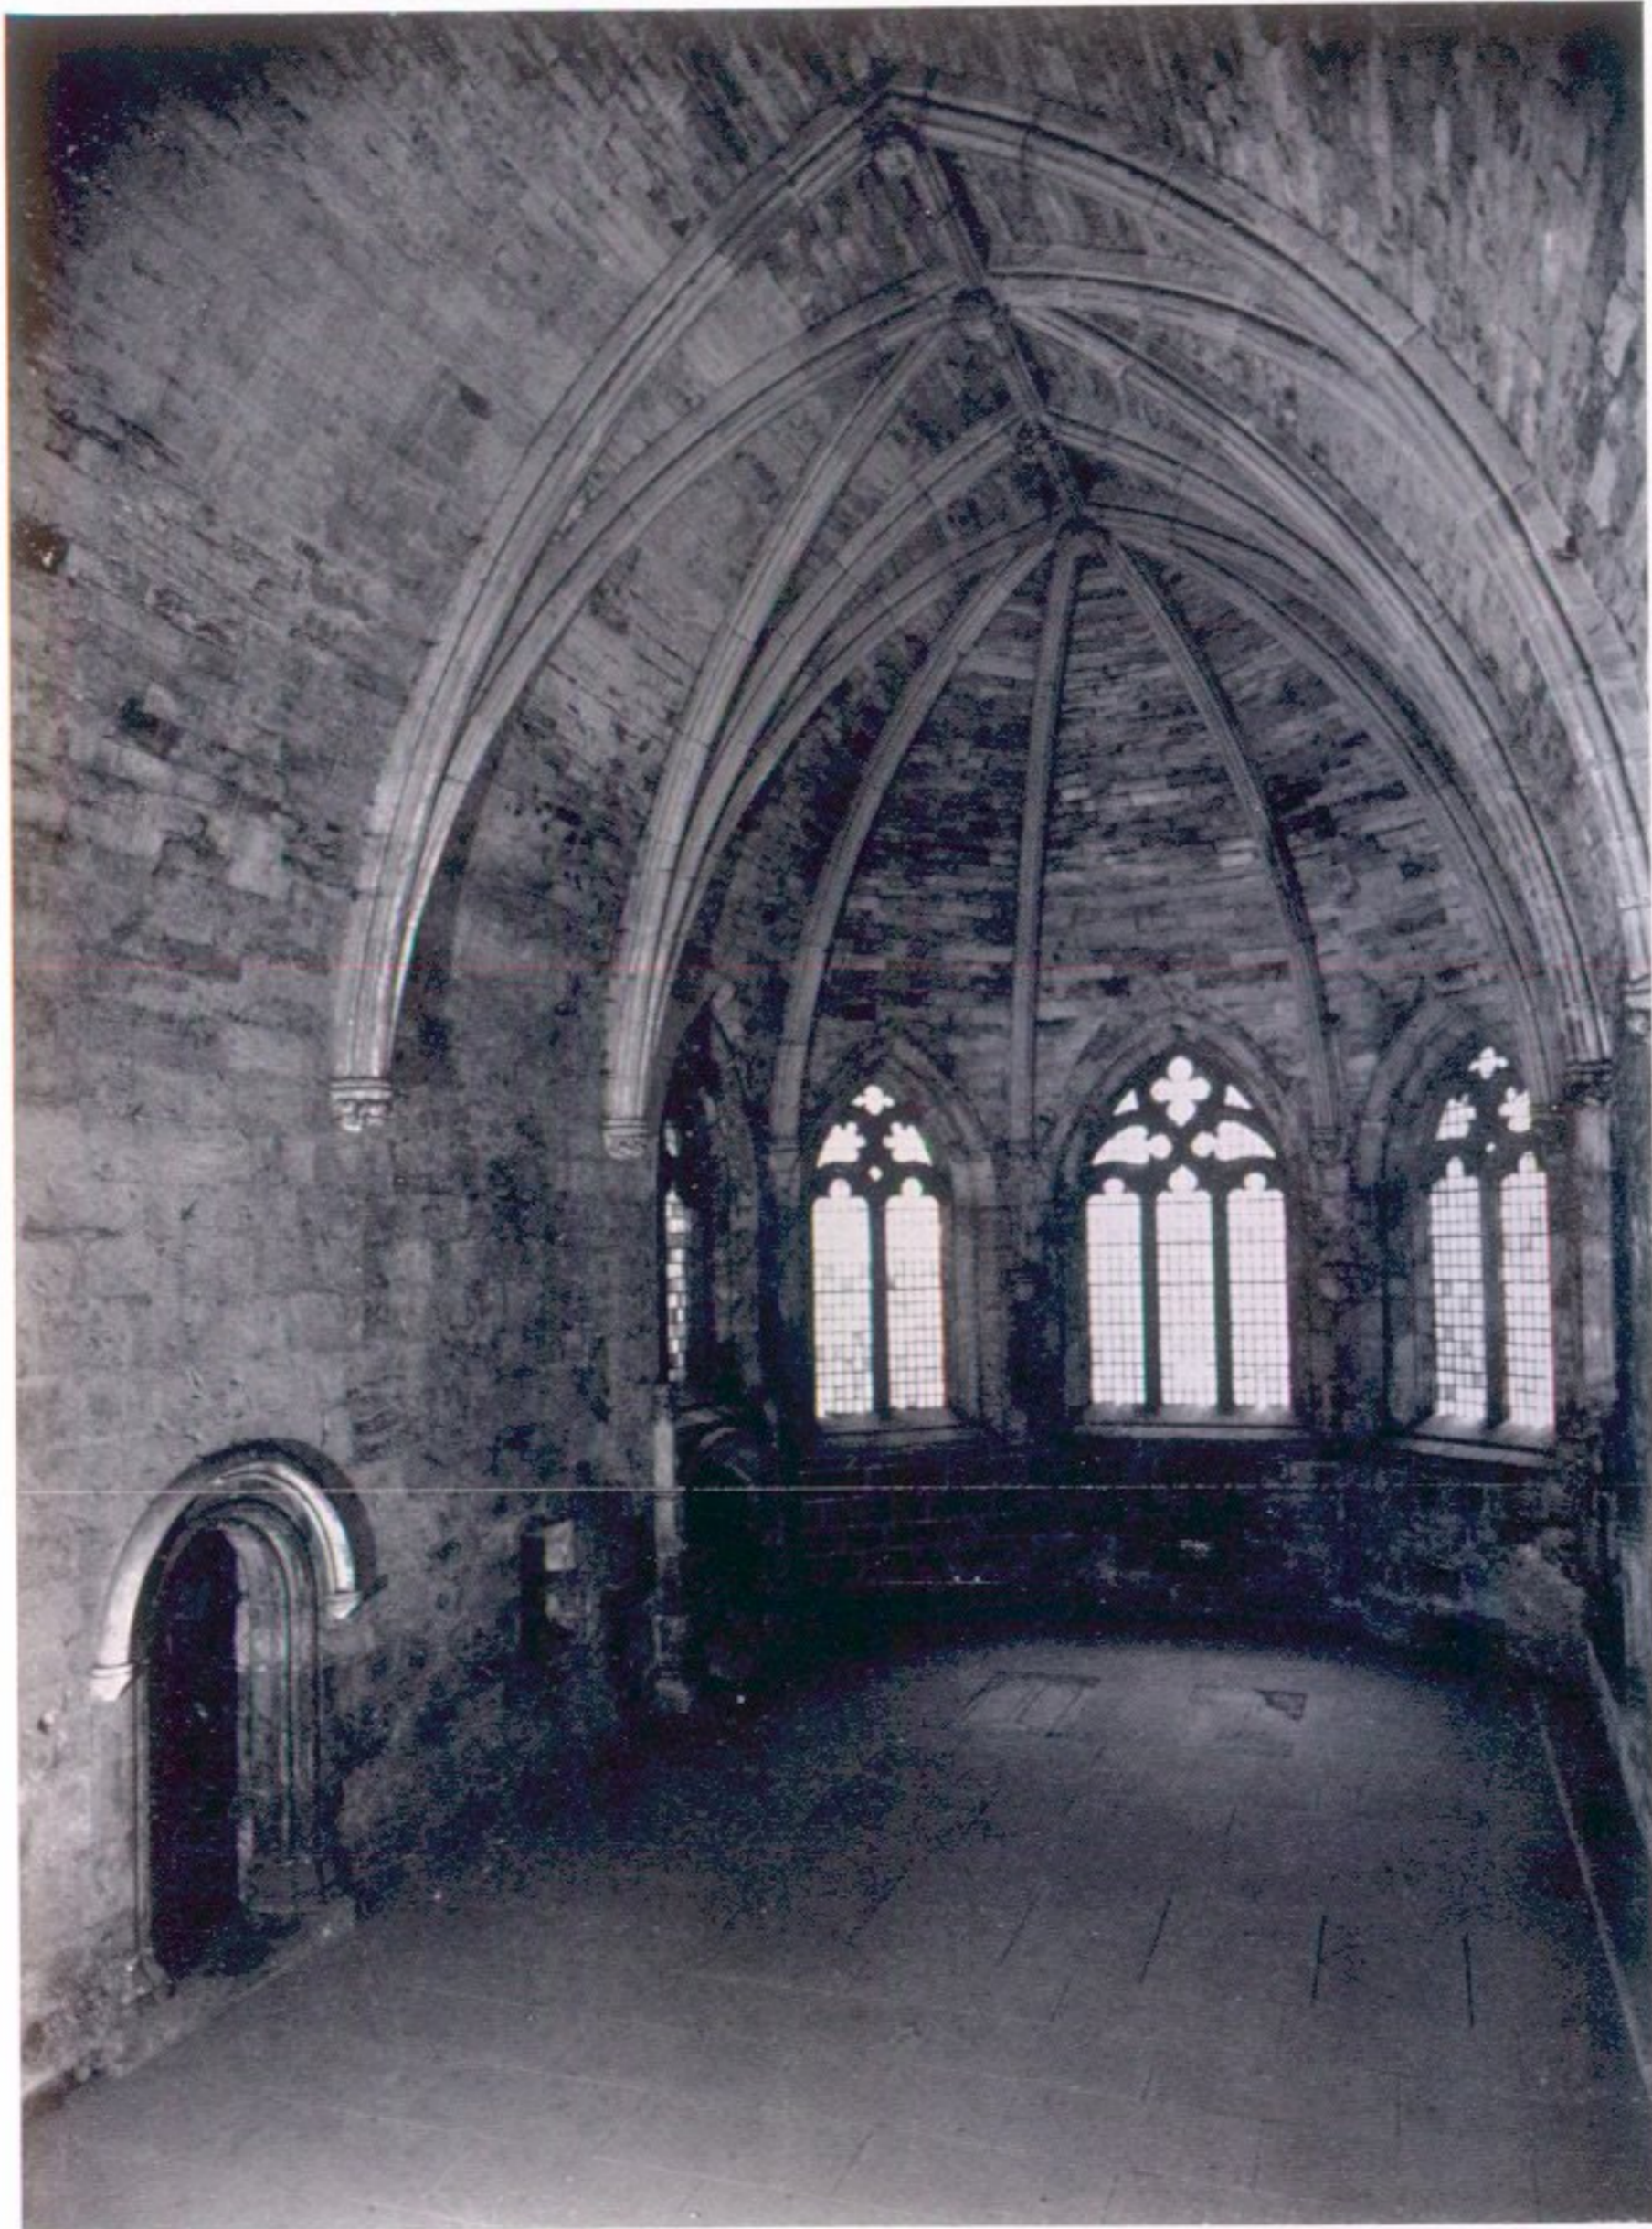
Seton Collegiate Church: the east end, 1470-8; vaulting 1478-1508.

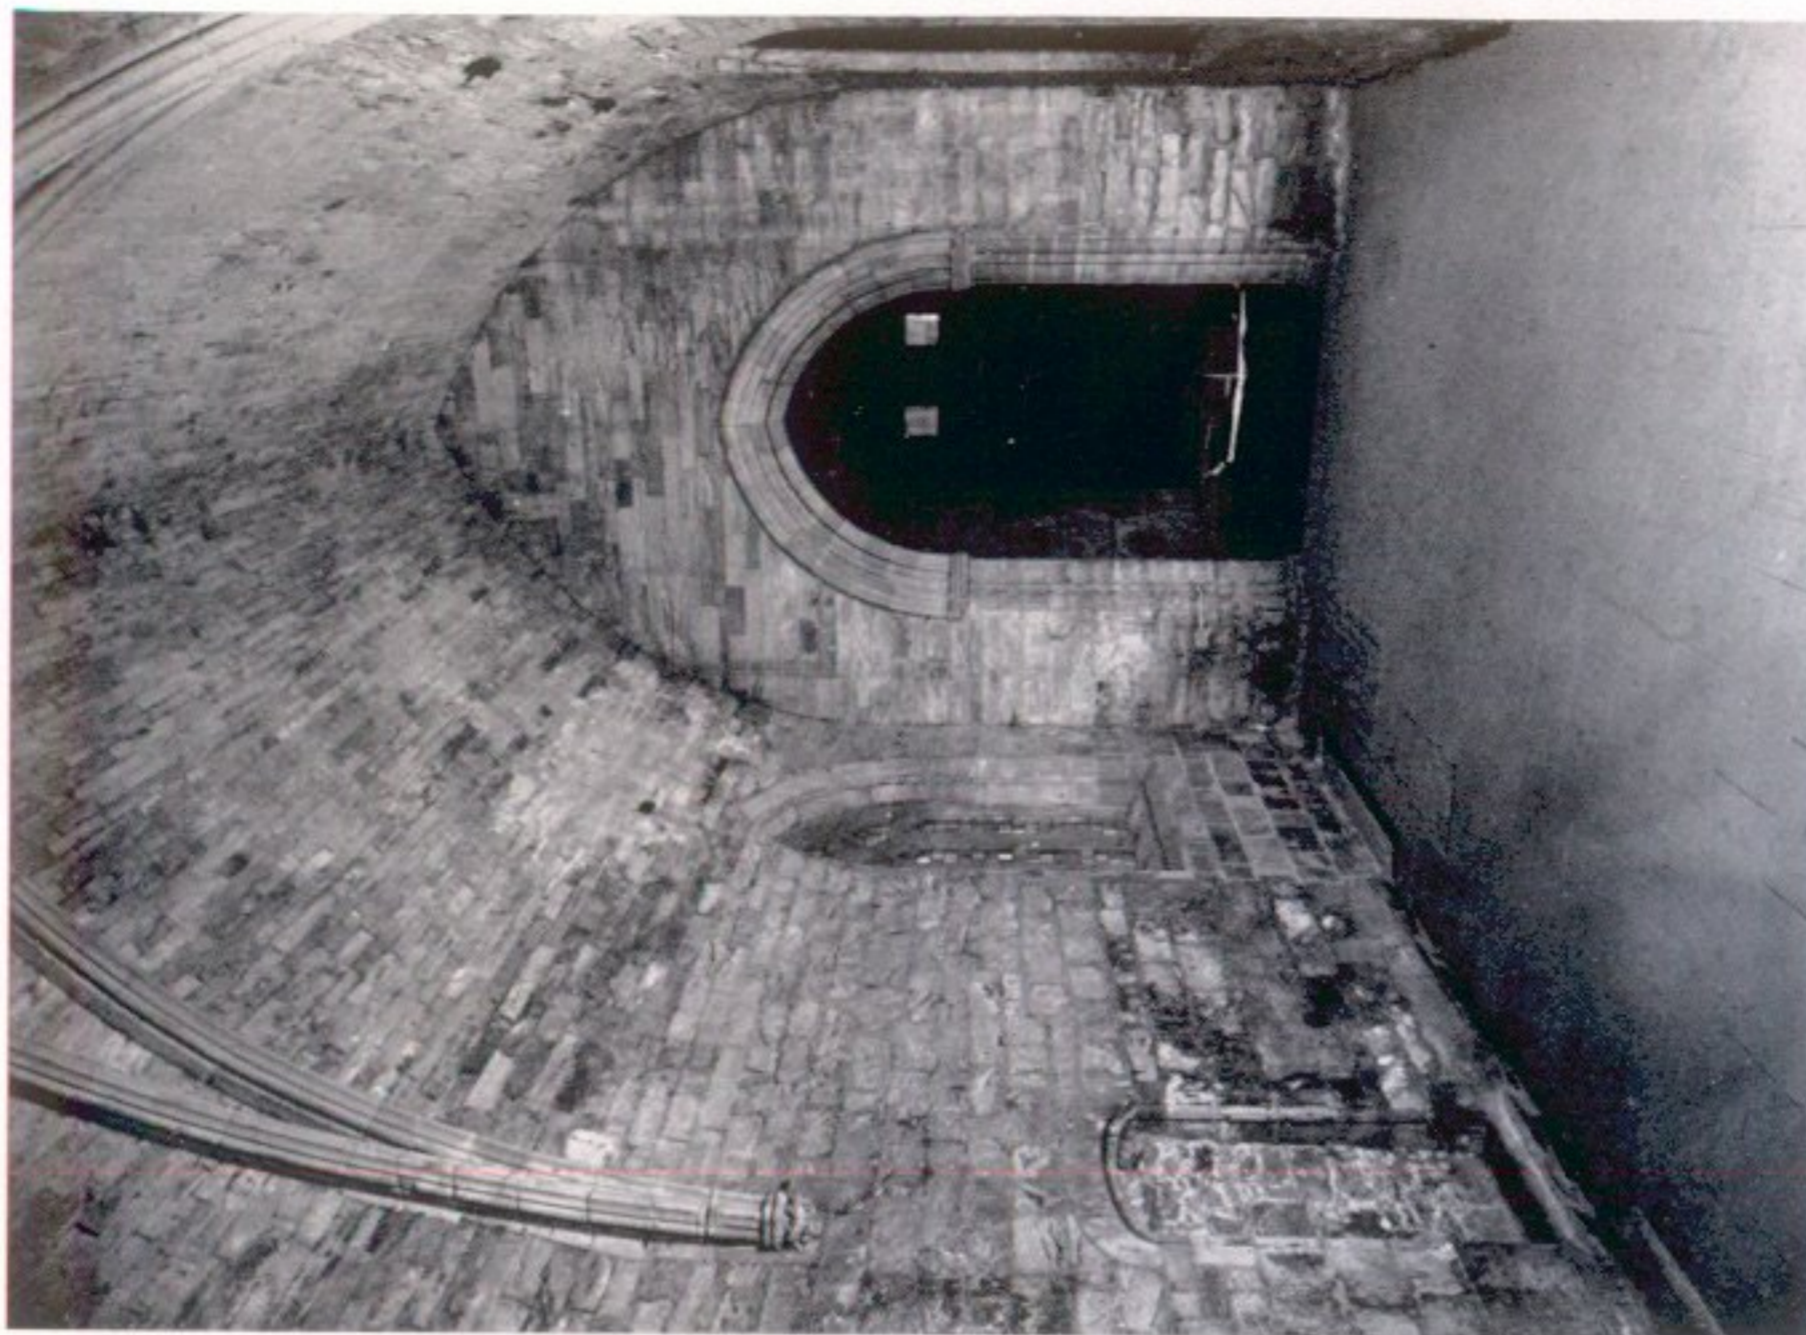
The choir and choir arch, looking west, floor relaid.

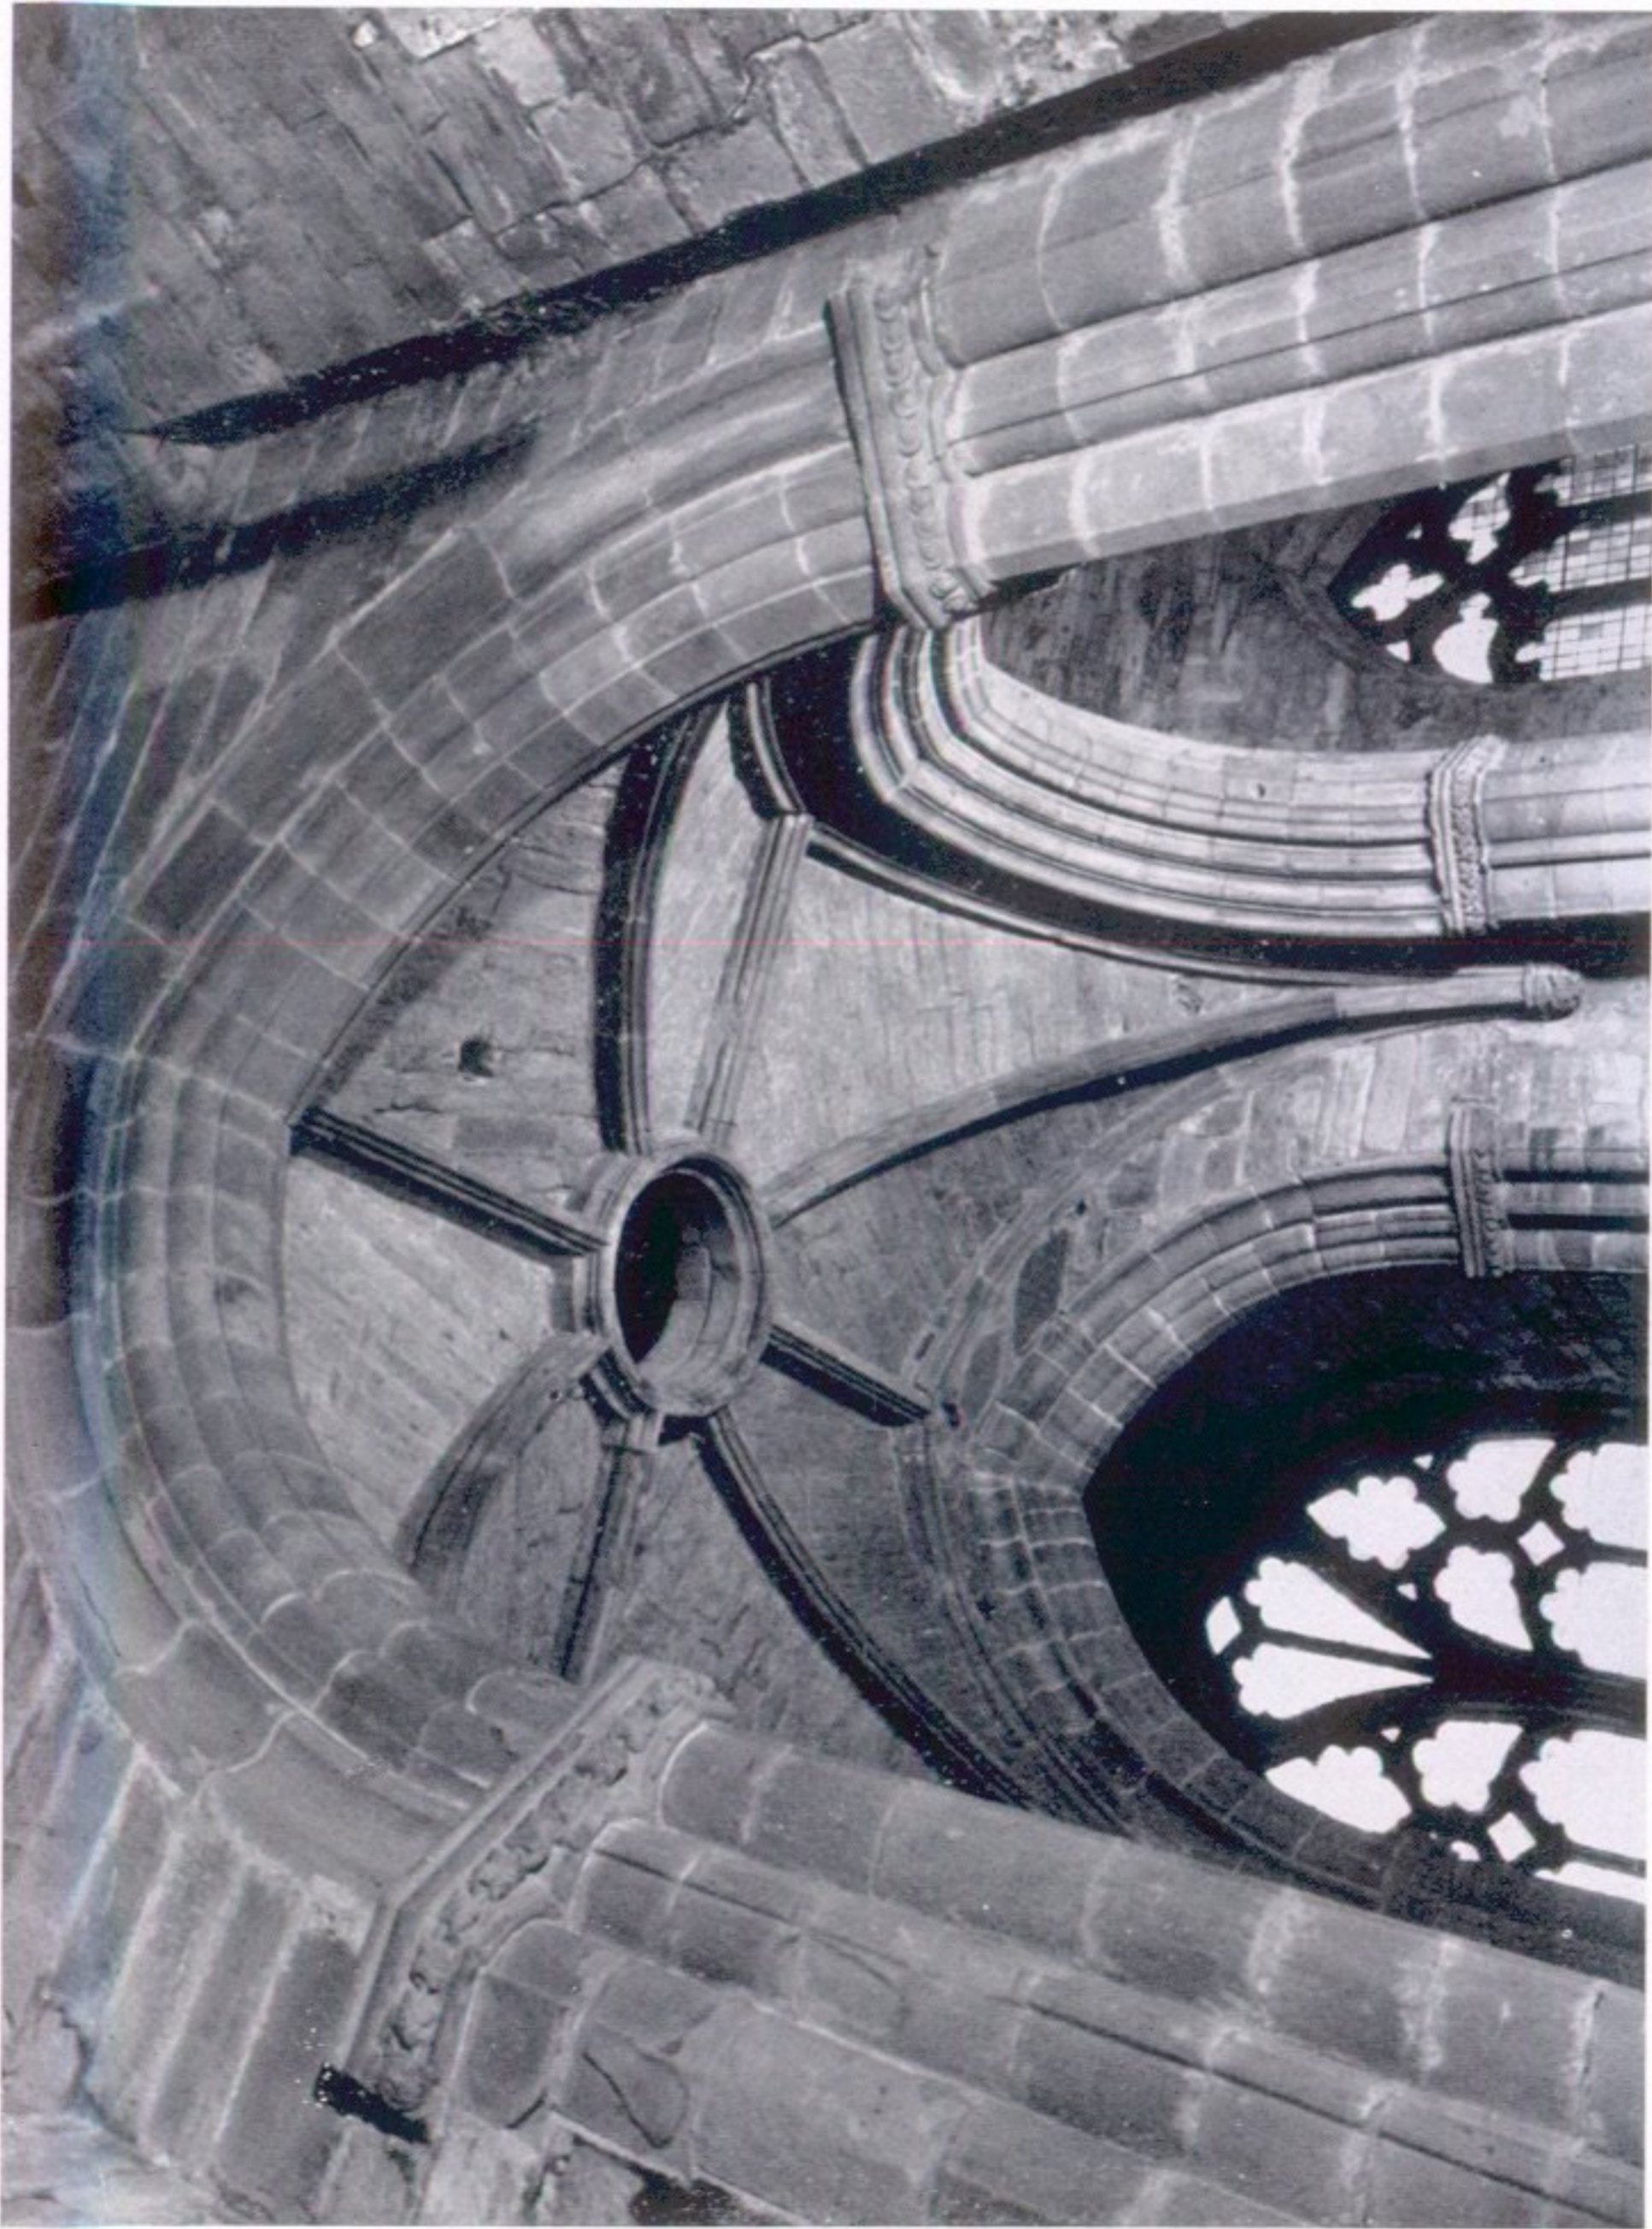
Seton Collegiate Church: the crossing from the south transept, 1513 x 1588; choir arch on right, 1470-8.

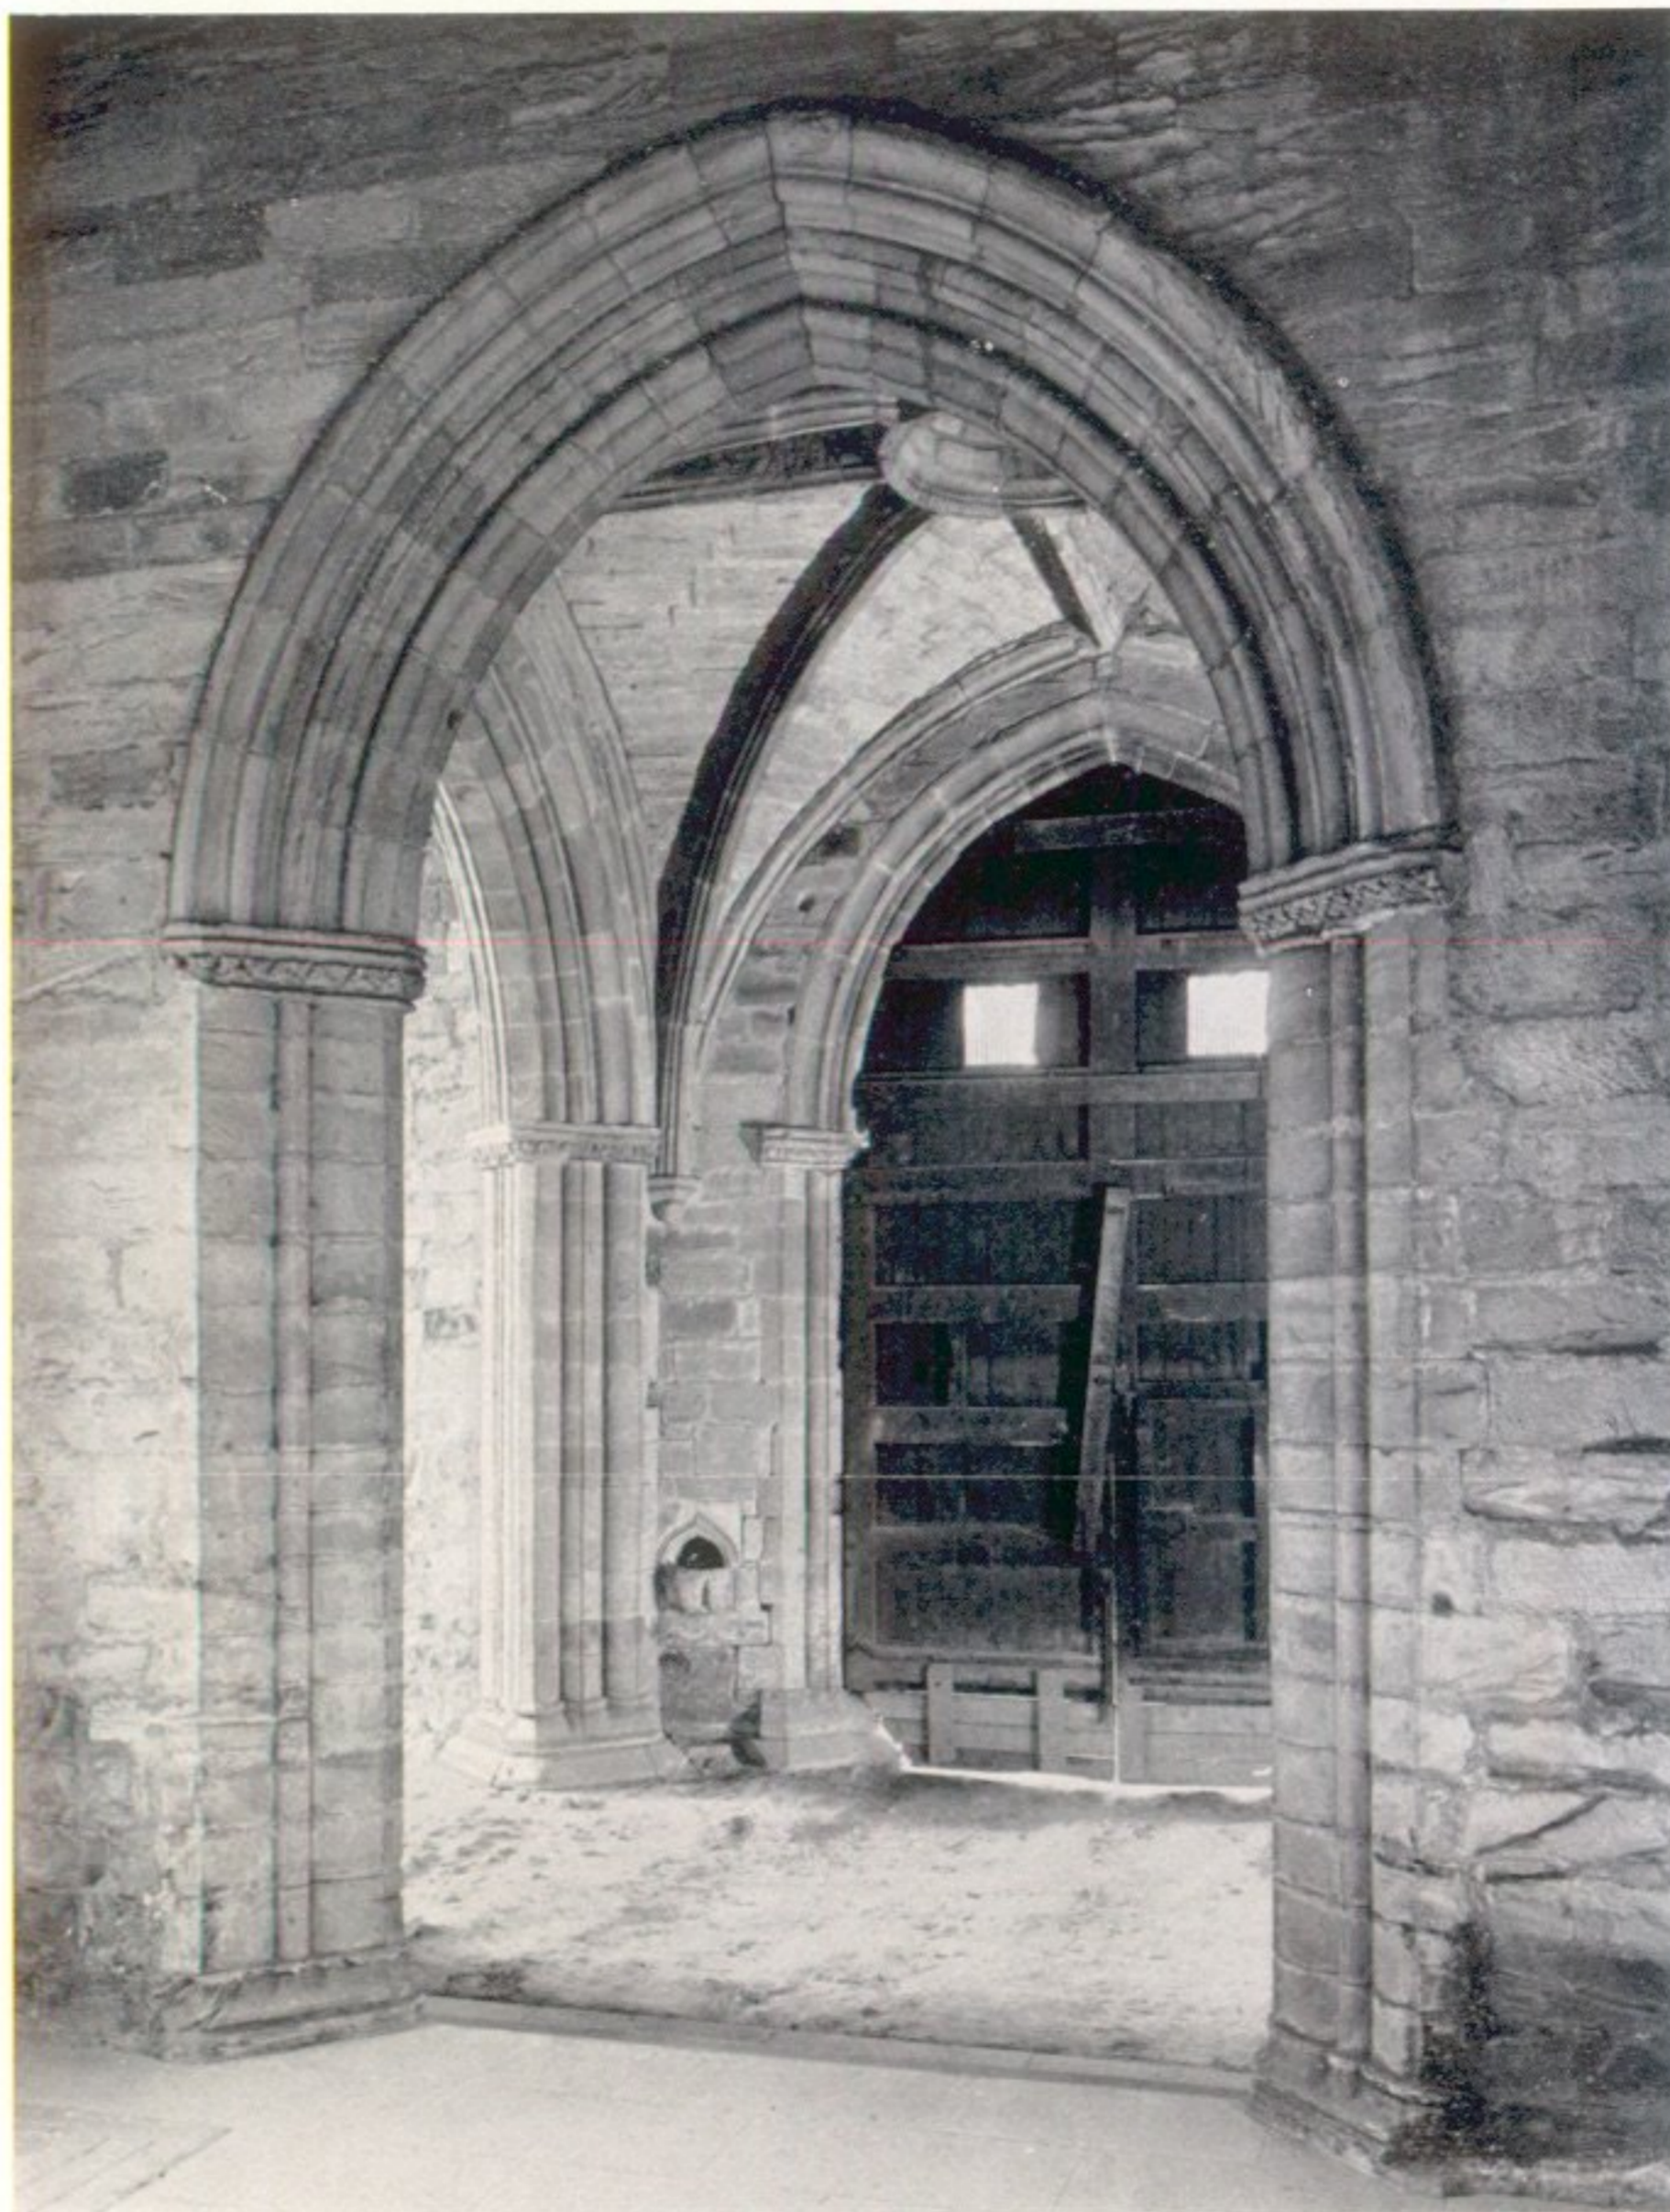
Seton Collegiate Church: the crossing from the choir; choir arch, 1470-8.

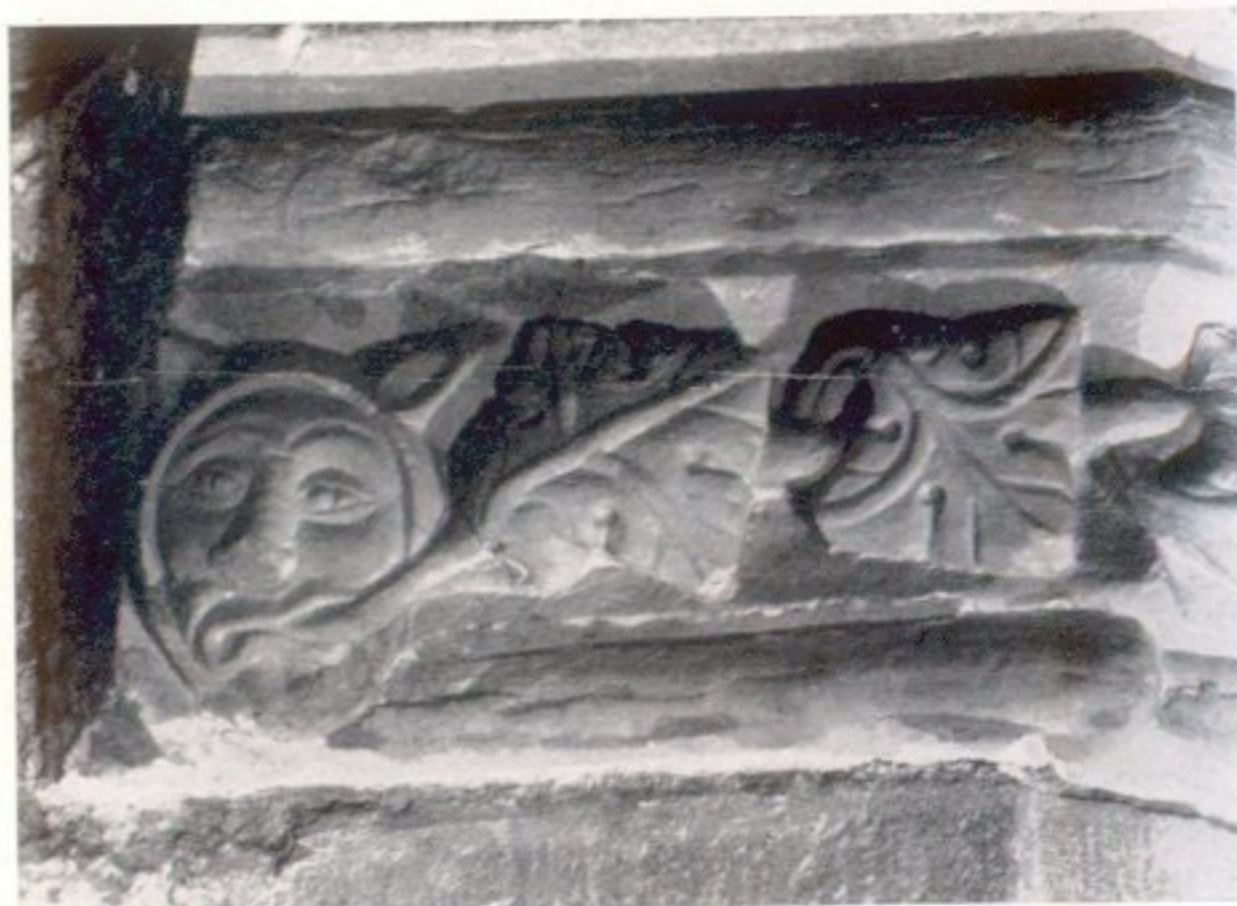
South transept arch. 1513 × 1588.

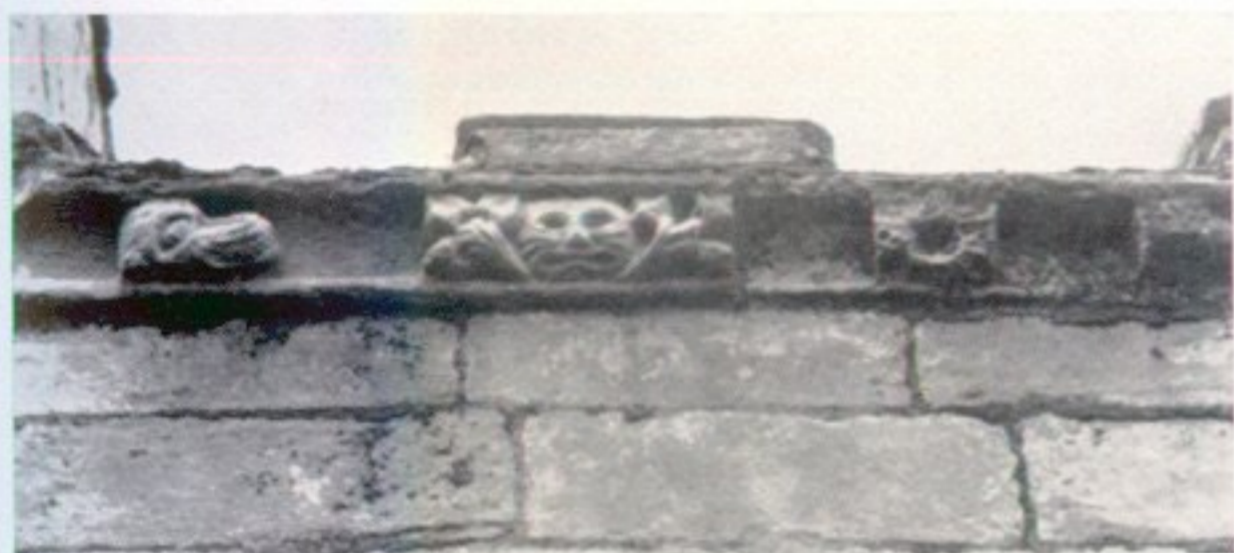
Cornice: east wall of north transept.  
1513 × 1588.

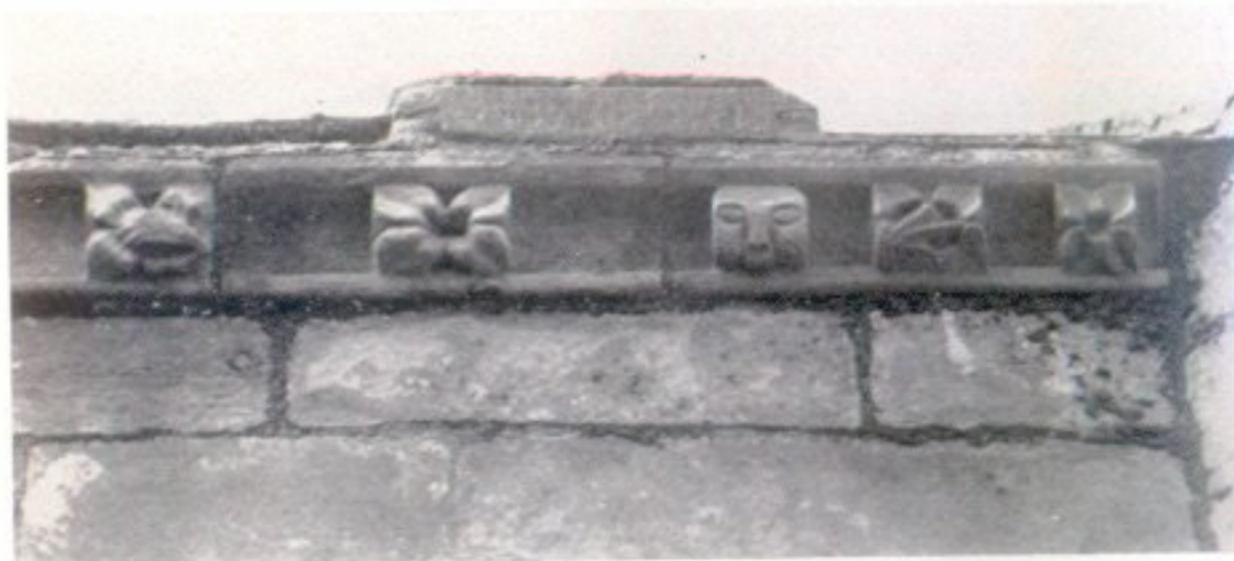
Cornice: east wall of north transept.  
1513 × 1588.

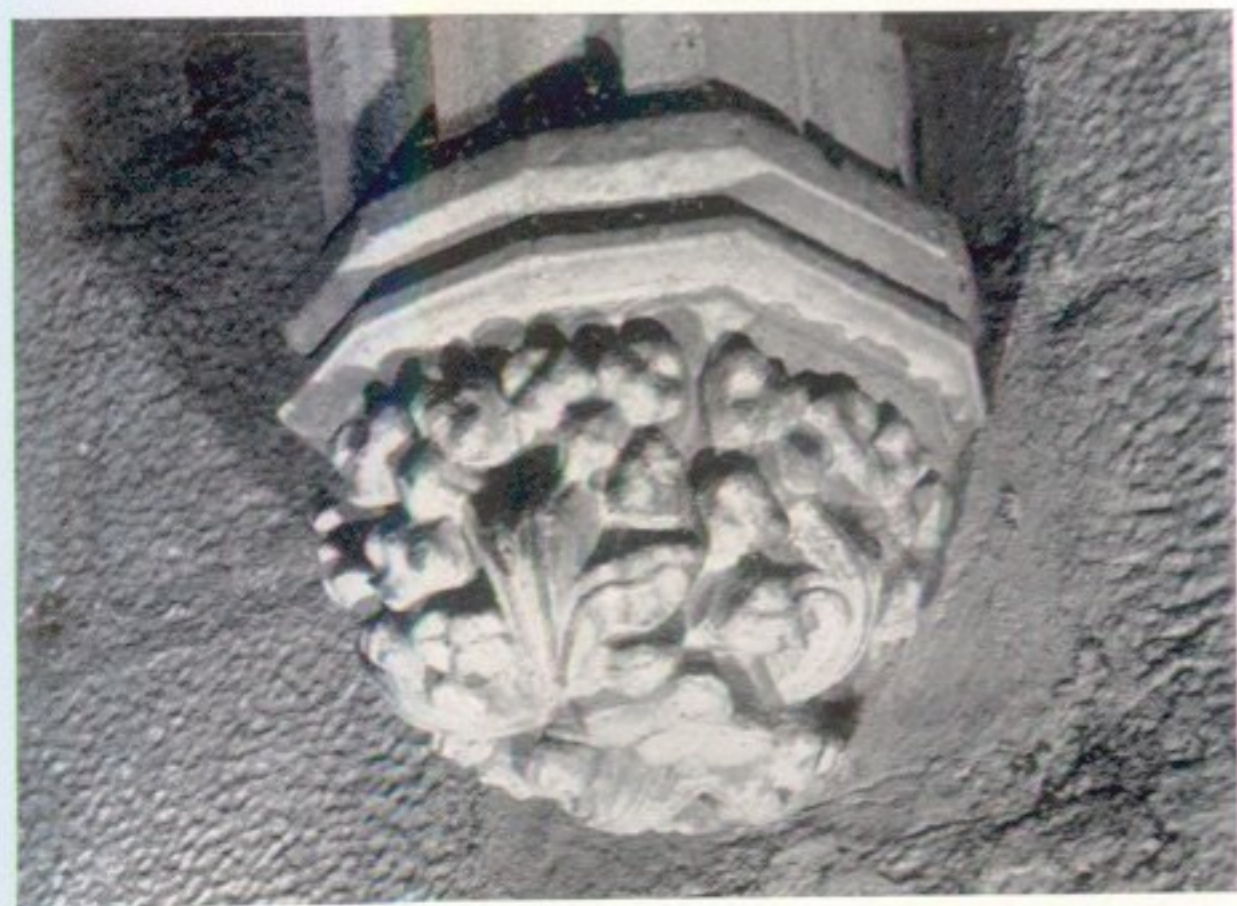
Chancel vault. 1478 × 1508.

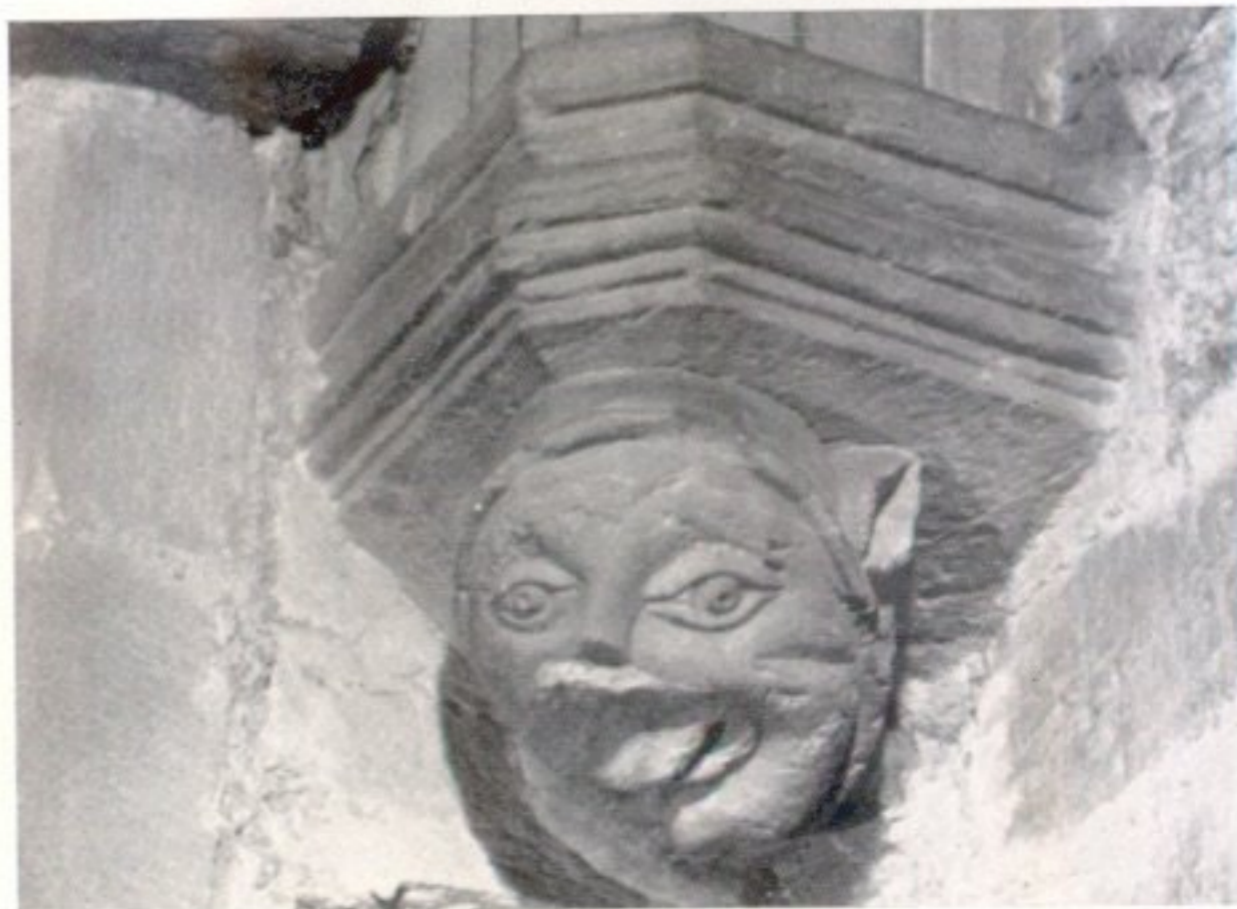
Vault of crossing. 1513 × 1588.
