SETON COLLEGIATE CHURCH.

By STEWART CRUDEN, A.R.I.B.A., F.S.A., F.S.A.Scot.,  
Inspector of Ancient Monuments for Scotland.

This paper is primarily an account of work done by the Ministry of Works, and particularly a discussion of problems raised by that work.

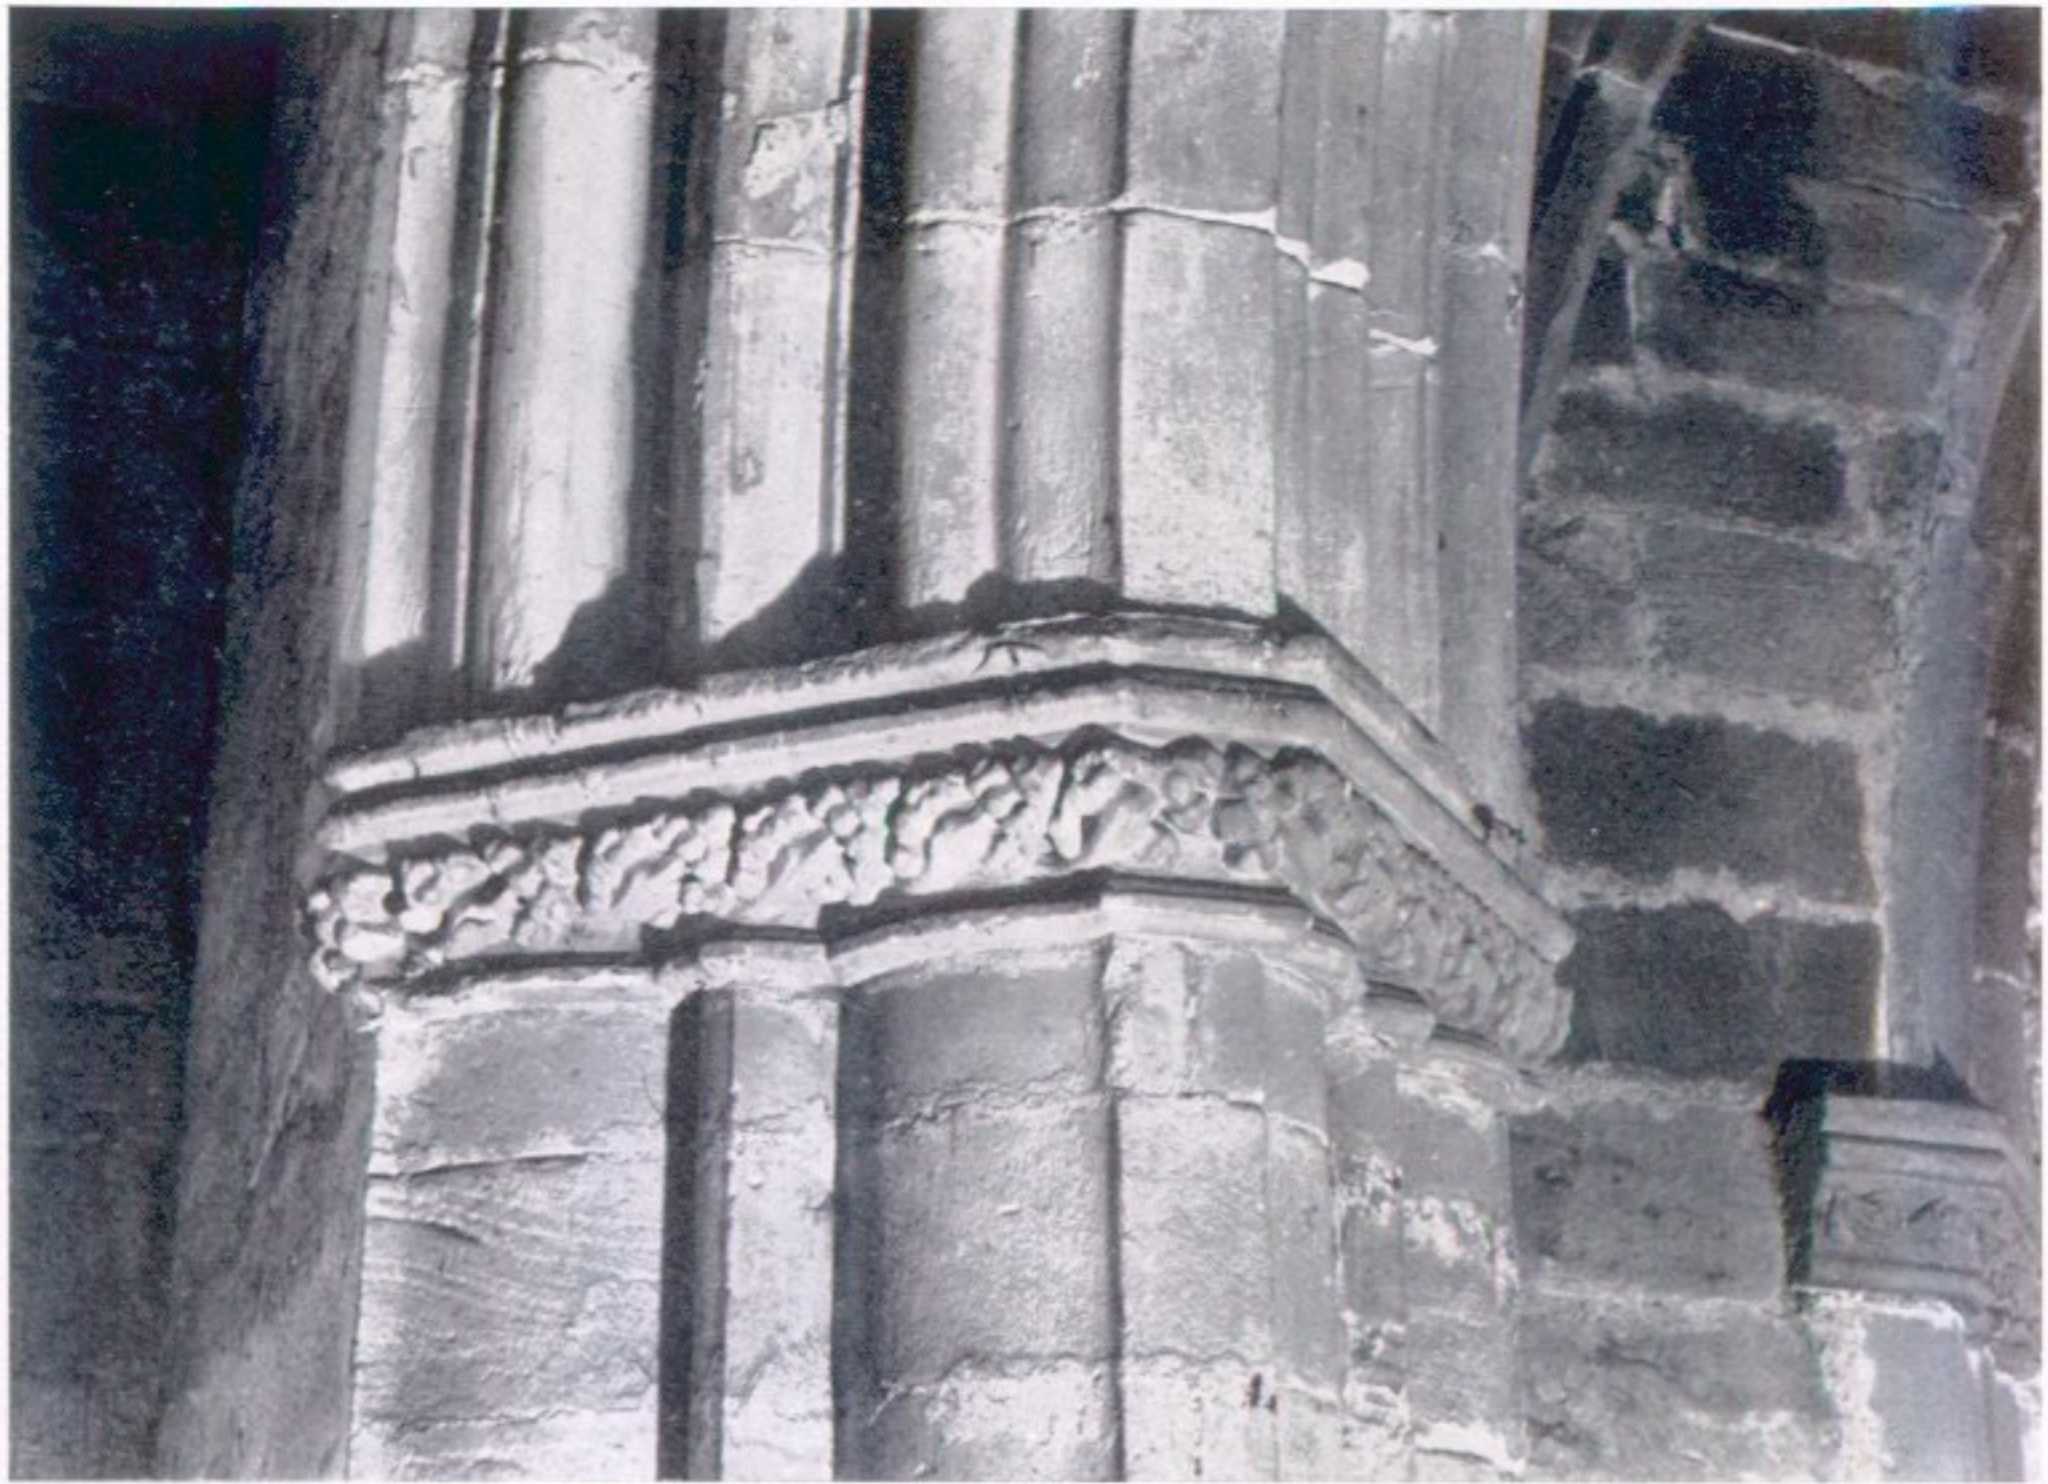
Choir arch: c. 1470-8.

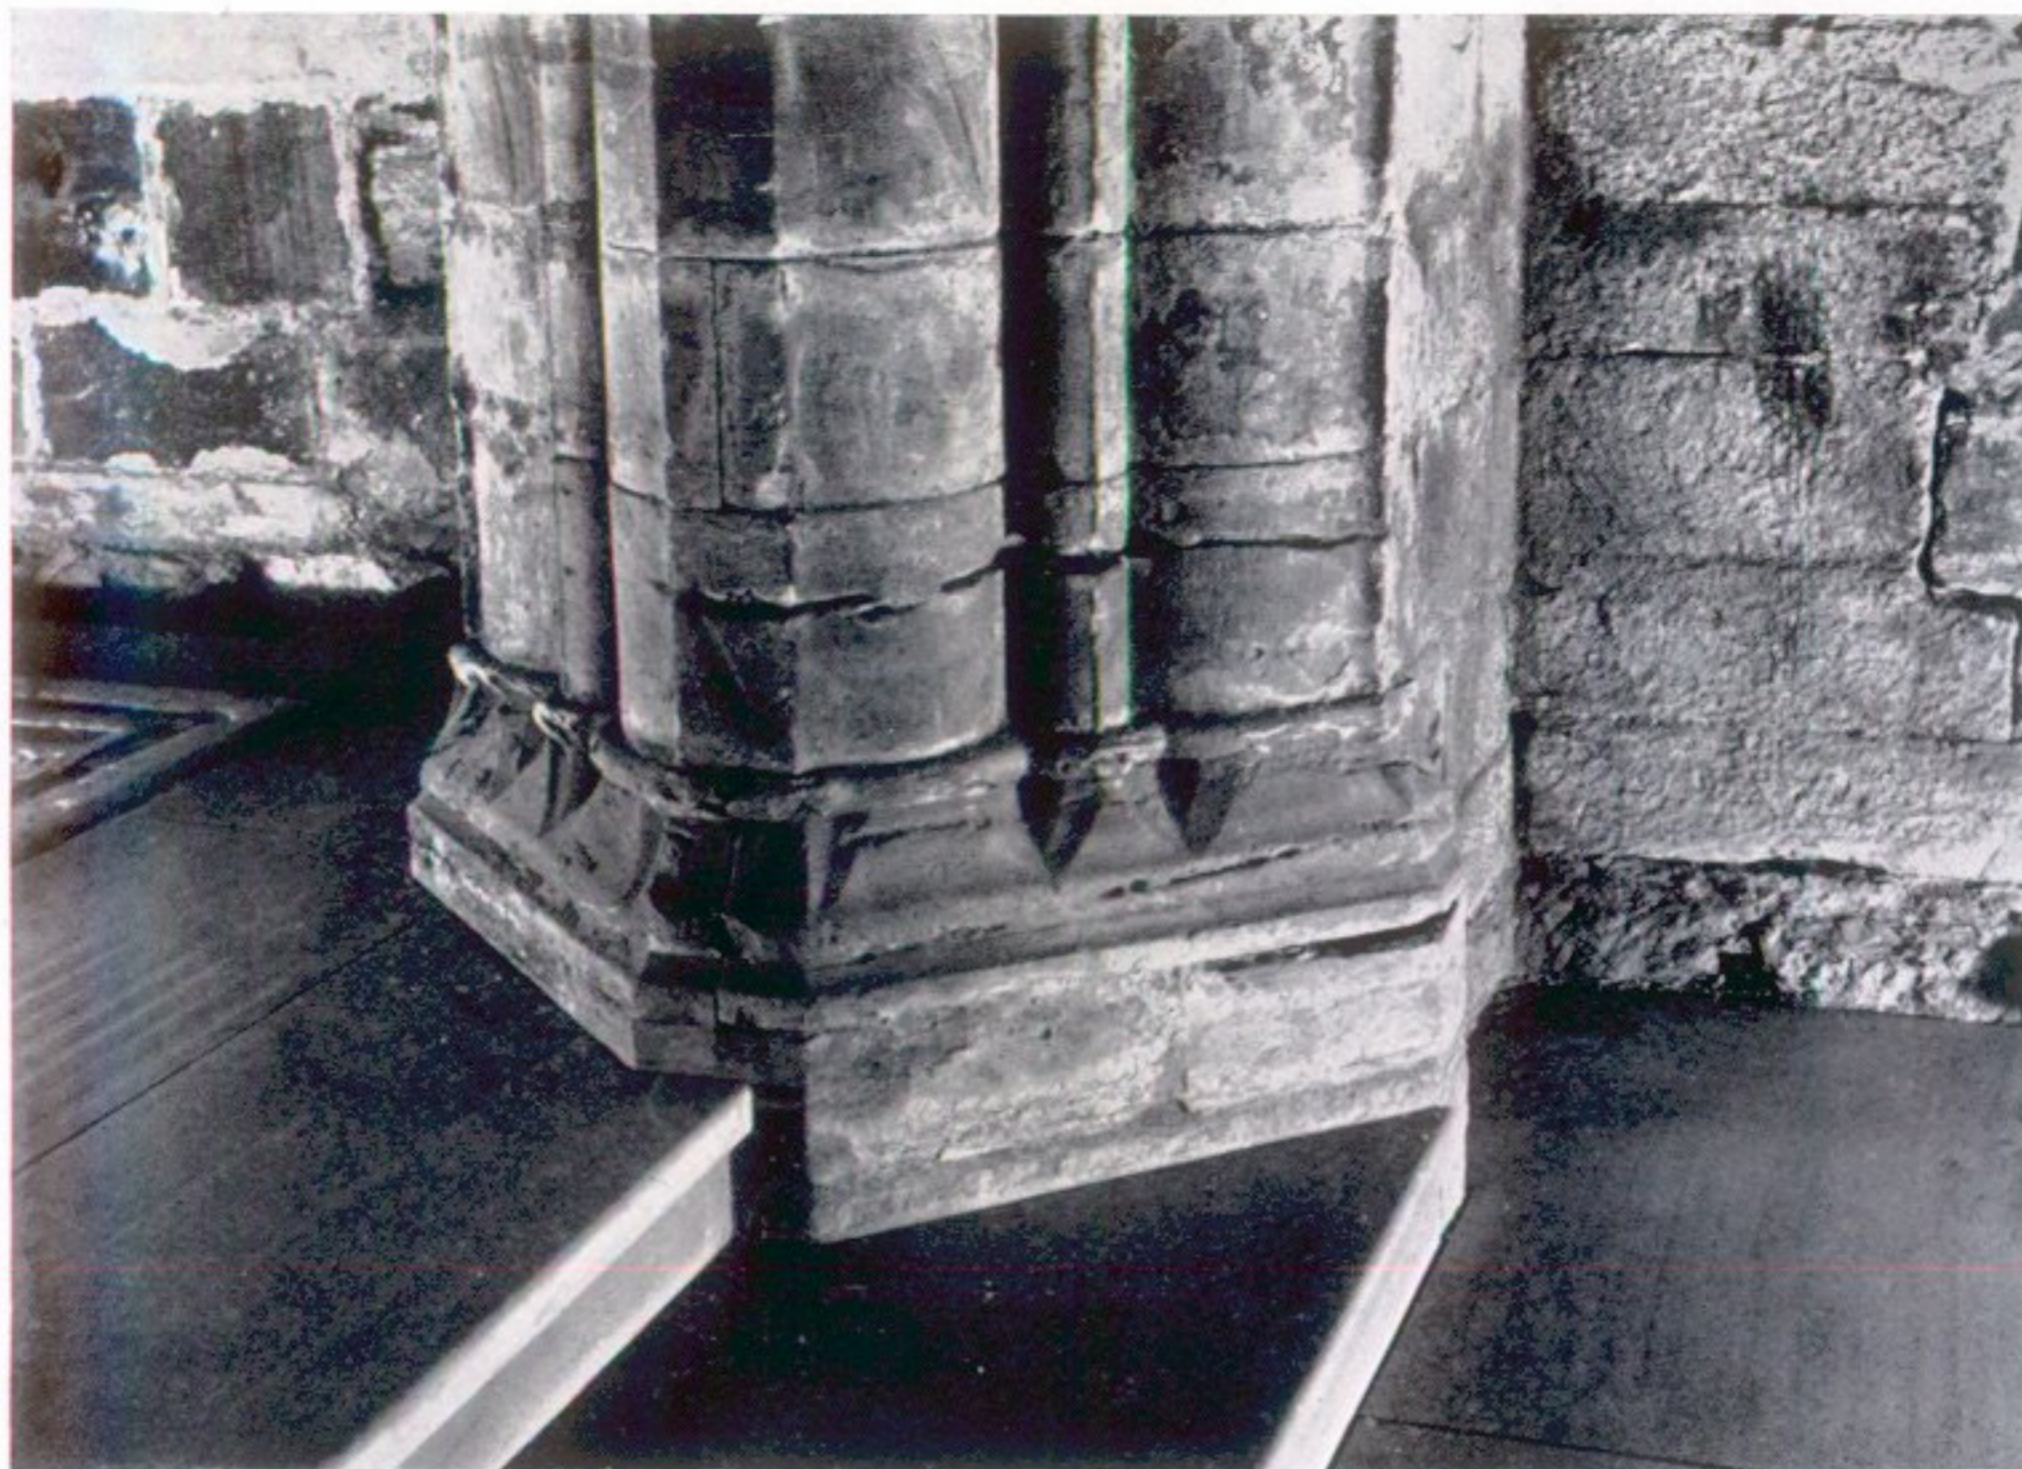
Choir arch: 1470-8.

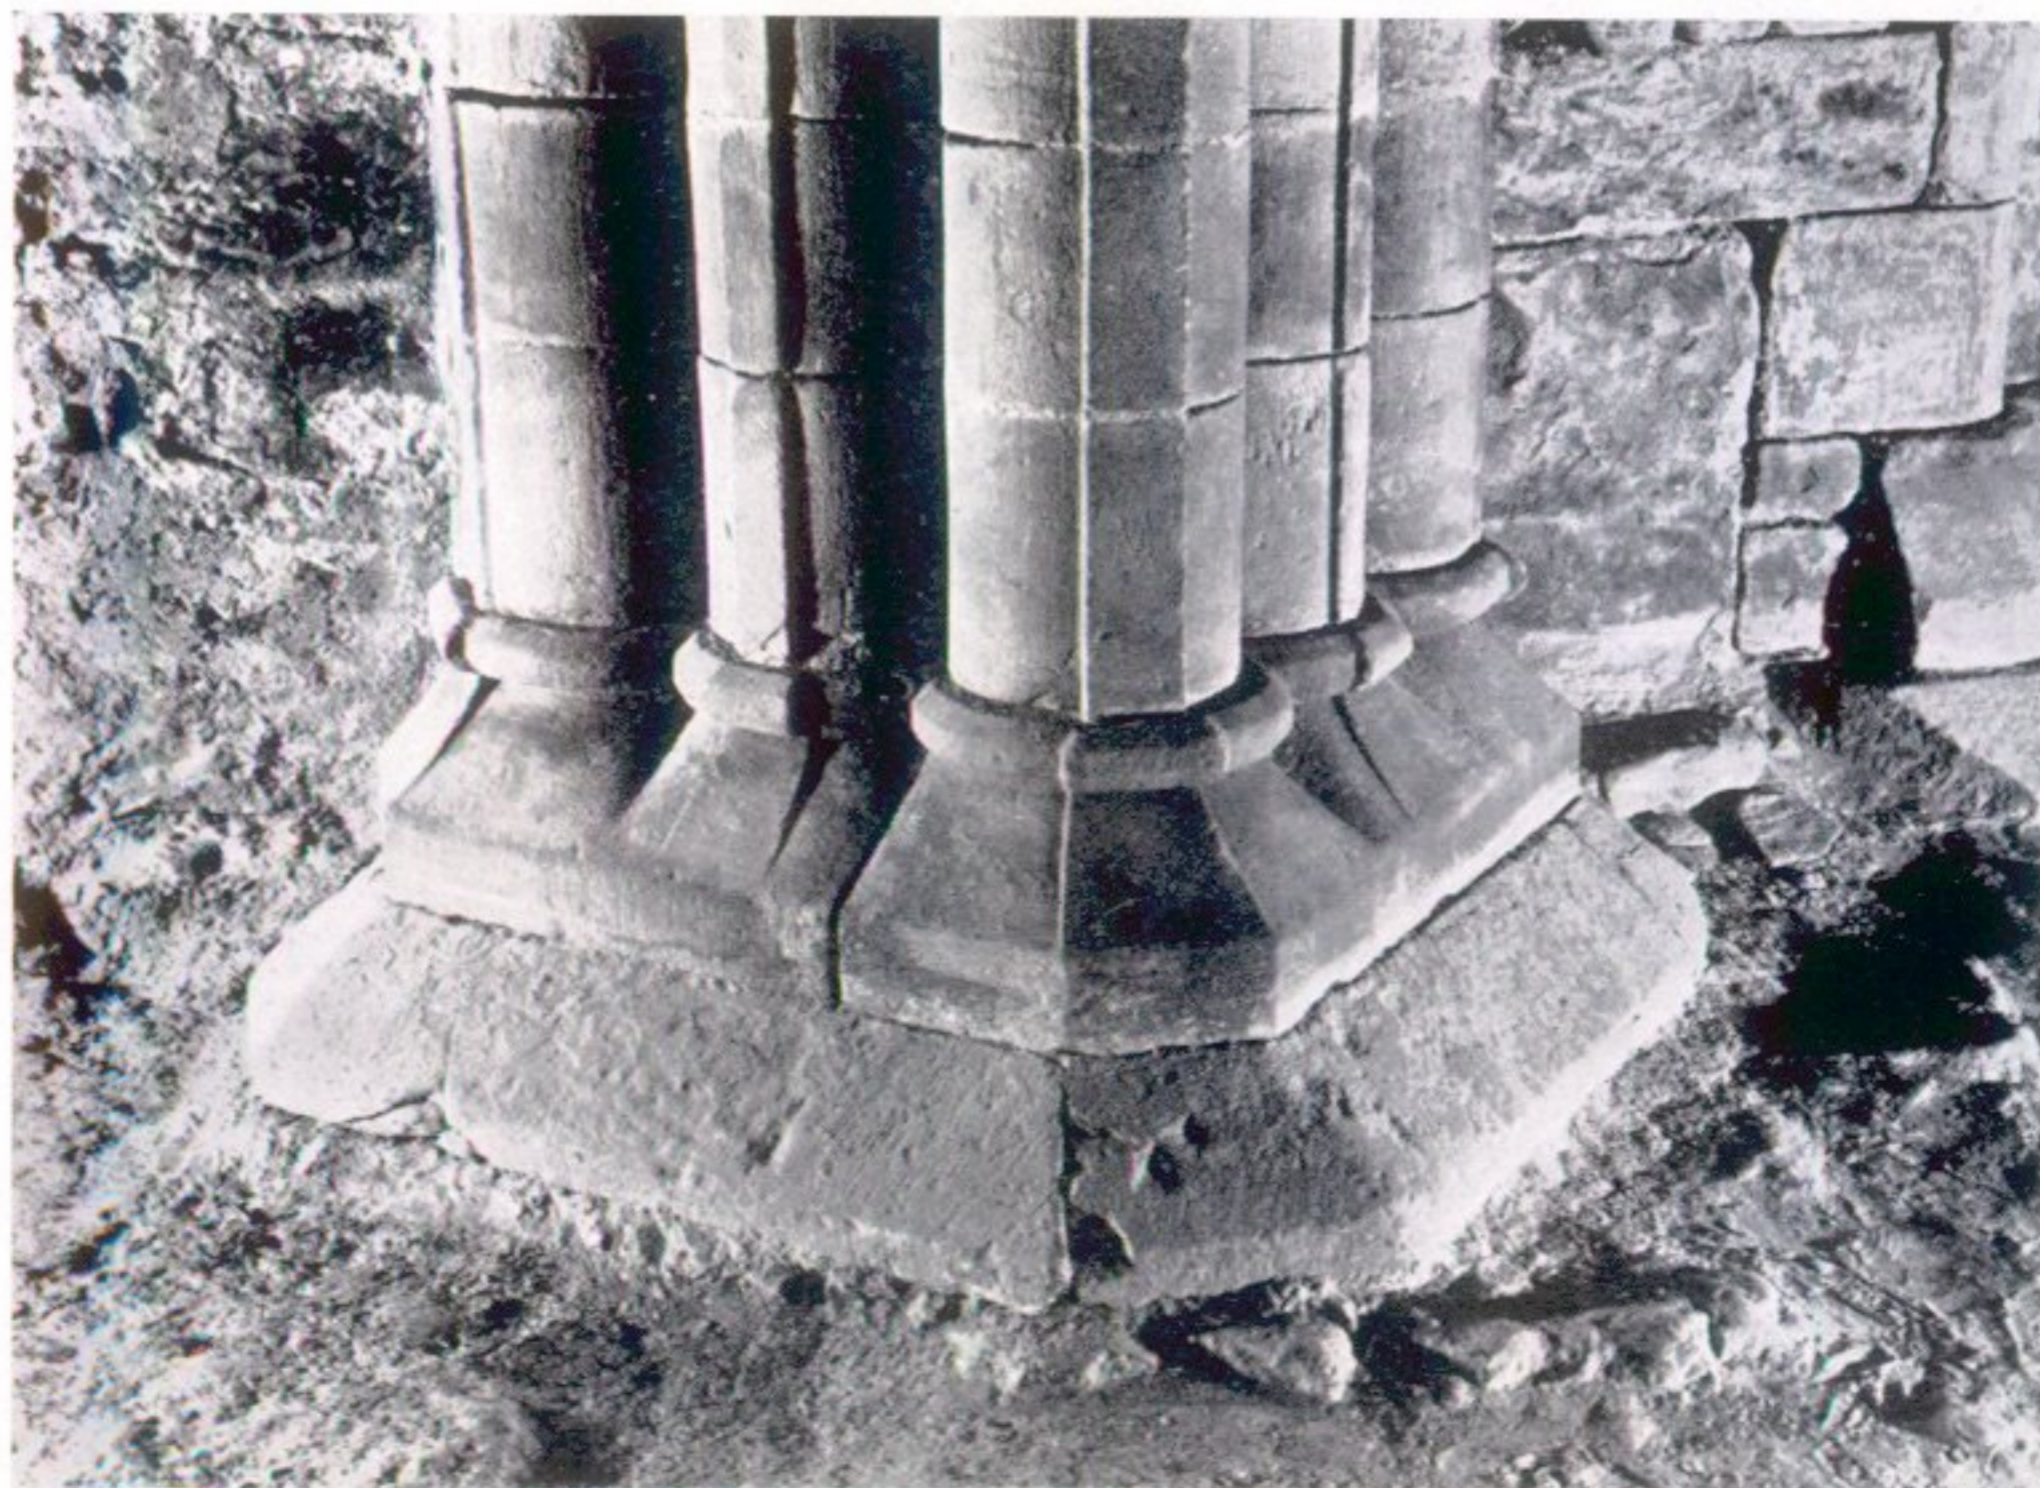
South transept arch. 1513 x 1588.

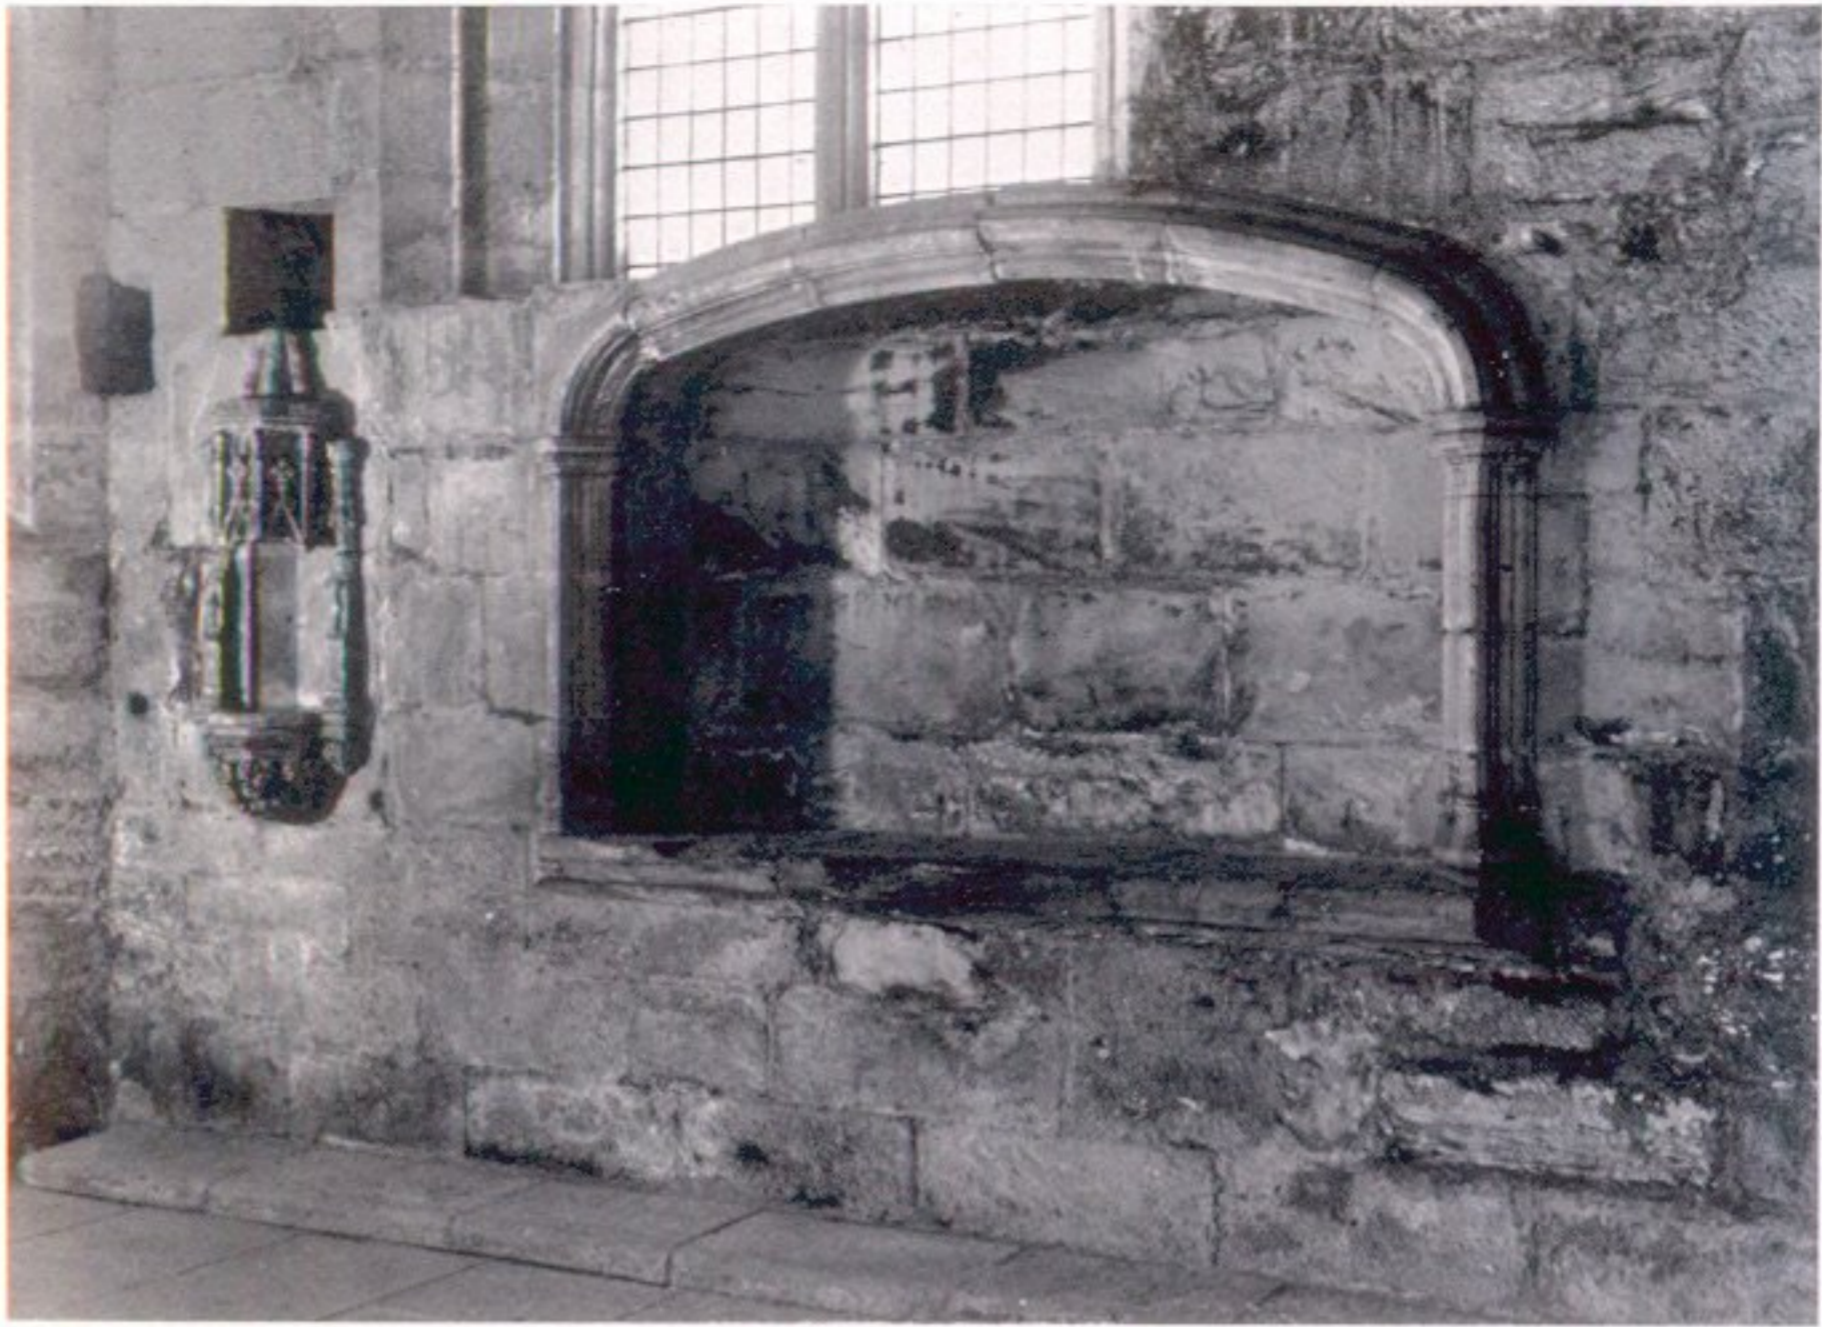
The sedilia: 1470-8.

Opposite the tomb-recess, in the south wall of the chancel, is another recess which must be called a sedilia (Pl. LVIII), for it is where a sedilia ought to be, save in altitude. The unusual and apparently inconvenient height above floor level casts doubt on this identification. The only plausible alternative for this sort of recess, so high up, is an Easter Sepulchre, but to this possibility there is the unanswerable objection that the Easter Sepulchre was always on the north side, so much so that where none existed an ordinary tomb recess in the correct position was used, as has been described. With an original tomb-recess in the correct position, and that a position of special sanctity, abreast the High Altar, such as would be accorded the founder or eminent benefactor, the likelihood of this "sedilia" being an Easter Sepulchre is remote. It must perforce be accepted for what it seems to be, whatever inconveniences attend its use. Probably they were overcome by the use of timber steps. Indeed, the use of timber steps and flooring in the choir, sanctuary, and transeptal altars, is a very probable explanation of the lack of evidence of their steps and floor levels. The High Altar platform would then advance towards the presbytery upon two or three steps probably carried round three sides of it, in the manner of an apron stage. The stalls of the ritual choir were probably backed against the blank side walls between the windows at the west end of the eastern limb and its north and south doors. These doors would serve as the *ostia presbyterii* of aisled choirs. But of the presbytery steps, the *gradus presbyterii*, and the choir screen, there is alike no evidence. All has vanished, it is reasonable to suppose, in the destruction of furniture and the upheaval of floor levels referred to above. The choir screen and stalls might have been further west, nearer the choir arch, with a longer presbytery. Their exact positions cannot be determined.

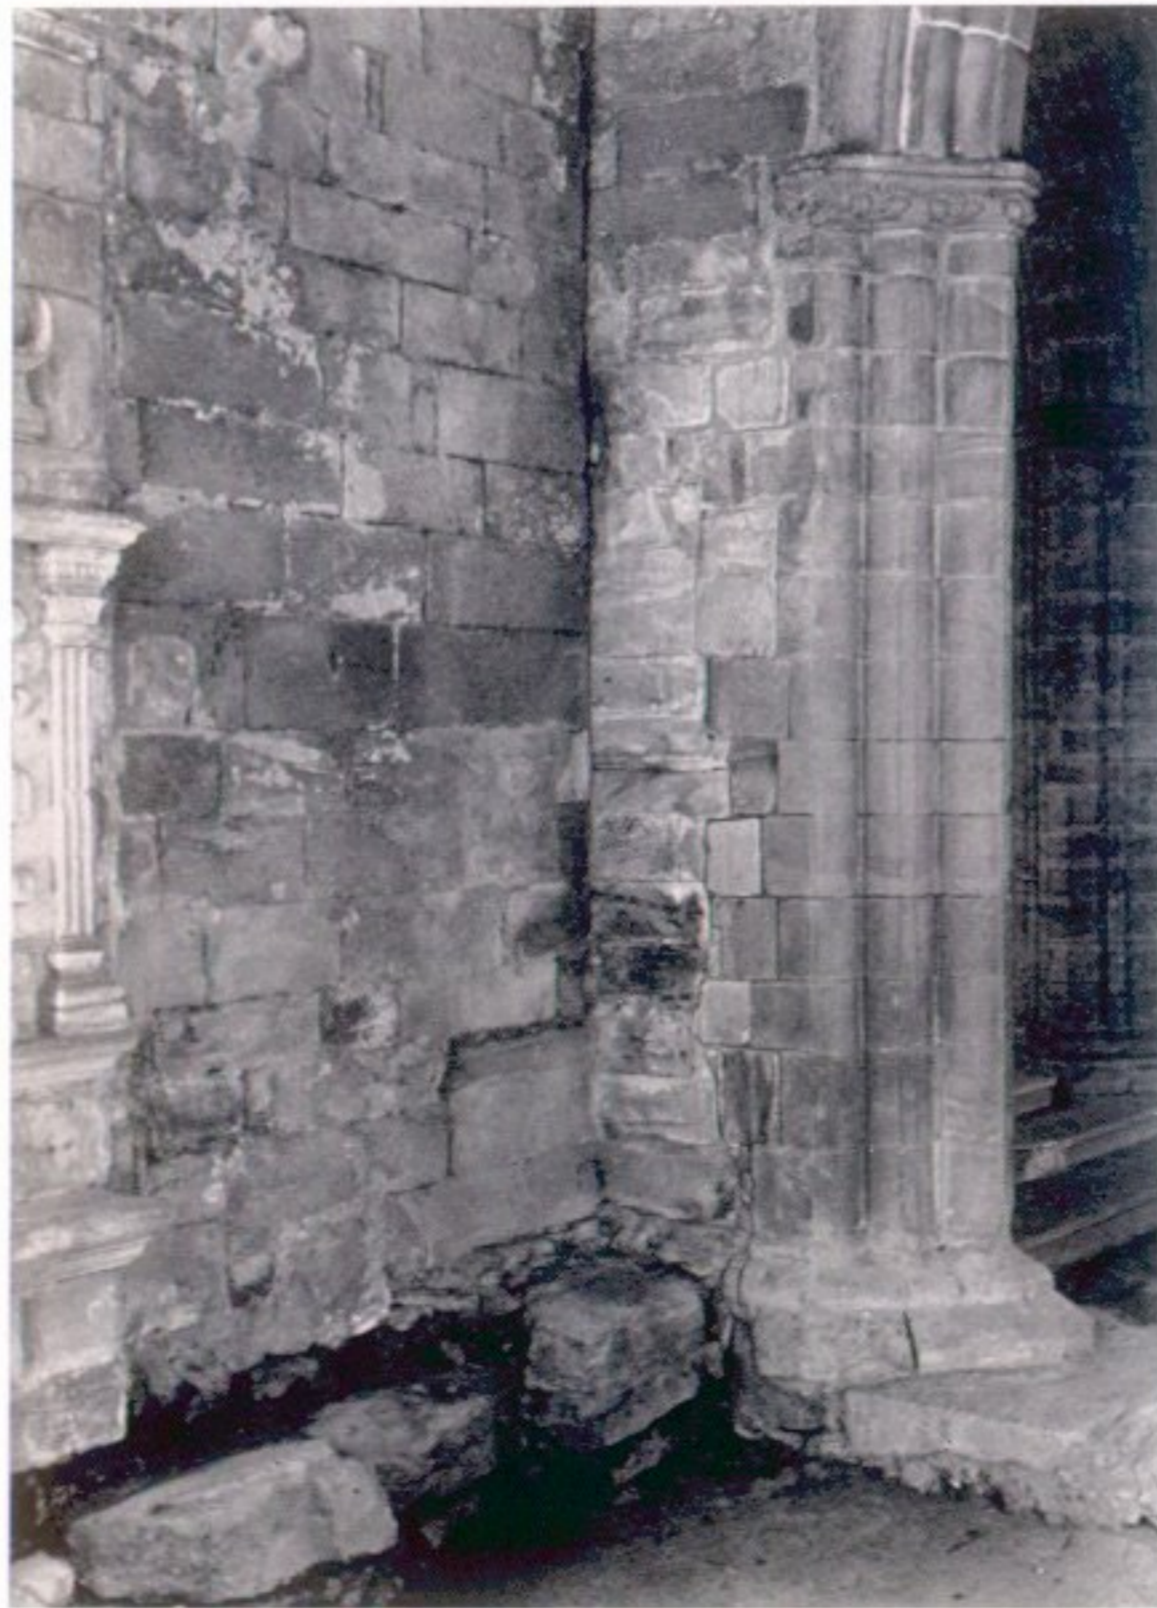
North transept: splicing of transept arch to older buttress  
Seton Collegiate Church.

The choir arch was blocked when the choir stood alone and at each of the western angles of the choir there were two boldly projecting buttresses similar to those which survive round the exterior of the choir and chancel to-day. These buttresses projected outwards from the corners, at right angles to one another, one pair to the N. and W., the other to the S. and W. When the transepts and crossing tower were added the buttresses were mutilated. The face-stones were drawn out and the shafts of the crossing arches were spliced into the body of the west buttresses. The buttresses projecting to N. and S. were more comprehensively dismantled when the east walls of the transepts were built against them. The evidence of the southern is lost in the stair turret in the north-east corner of the south transept, but the massive plinth of the northern is evident in the south-east corner of the north transept. The ragged junction of the buttresses and arch shafts is clearly to be seen (Pl. LVIII).

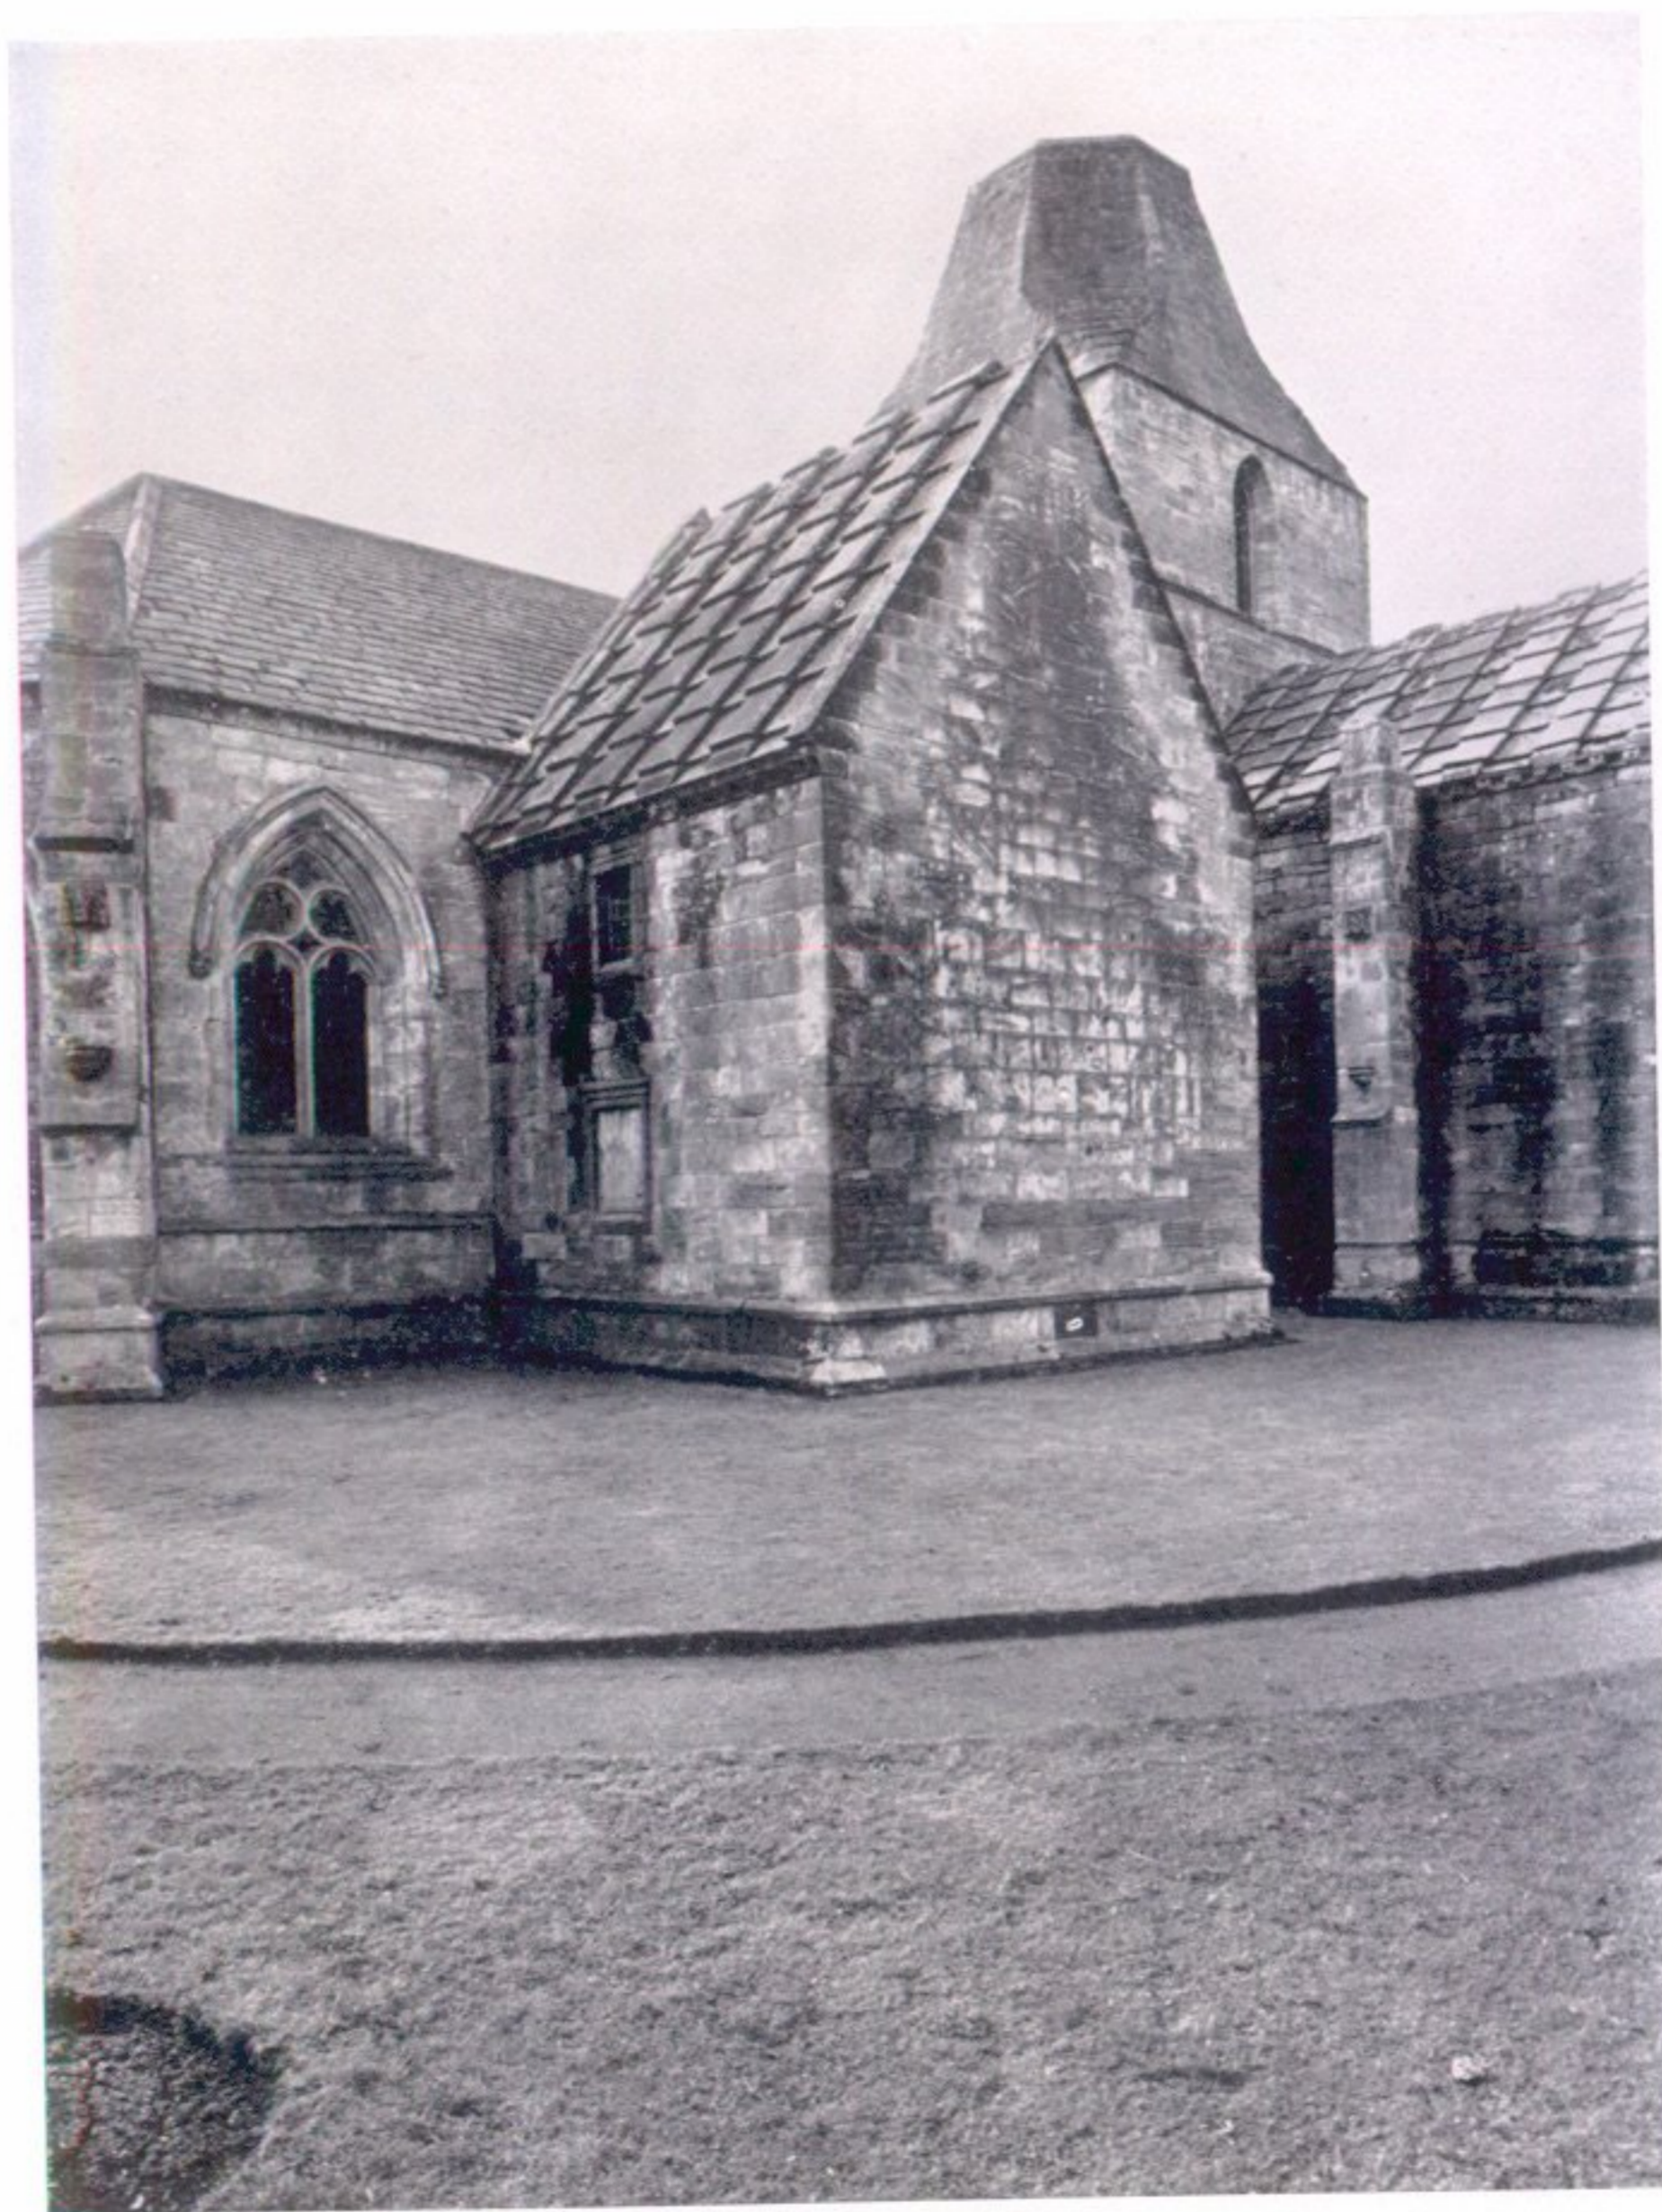
Seton Collegiate Church: the sacristy, 1470-8.

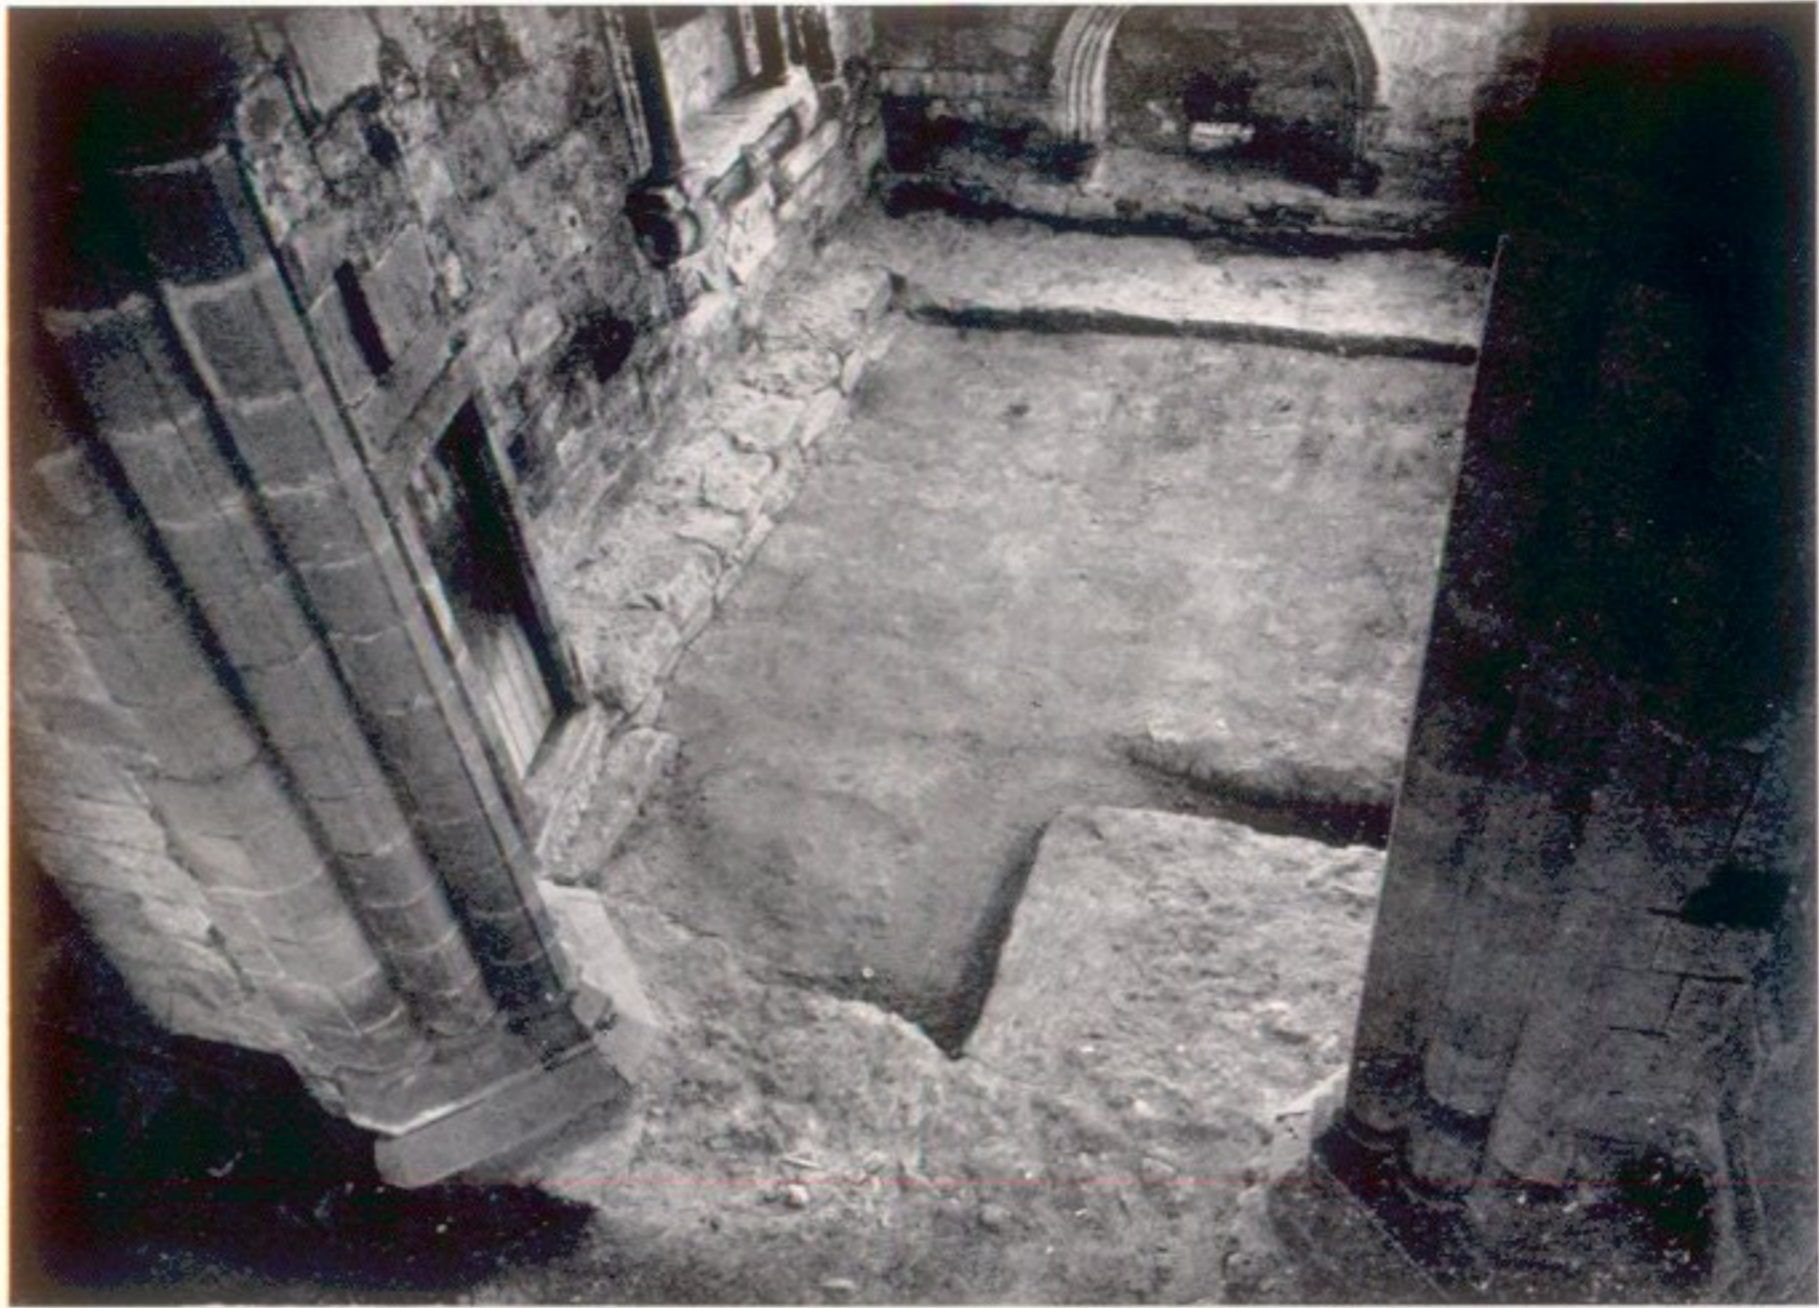
The south transept from the crossing tower showing older foundations.  
(See plan.)

They are visible outside the west wall of the transept; they run under it and reappear inside it (Pls. XLIX and LX). Only the rubble core-work of footings survives; there is no ashlar to assist identification and dating. But there can be little doubt that these foundations emerging from beneath the south transept represent the mid-15th-century aisle which was demolished by Lady Janet to make way for it.

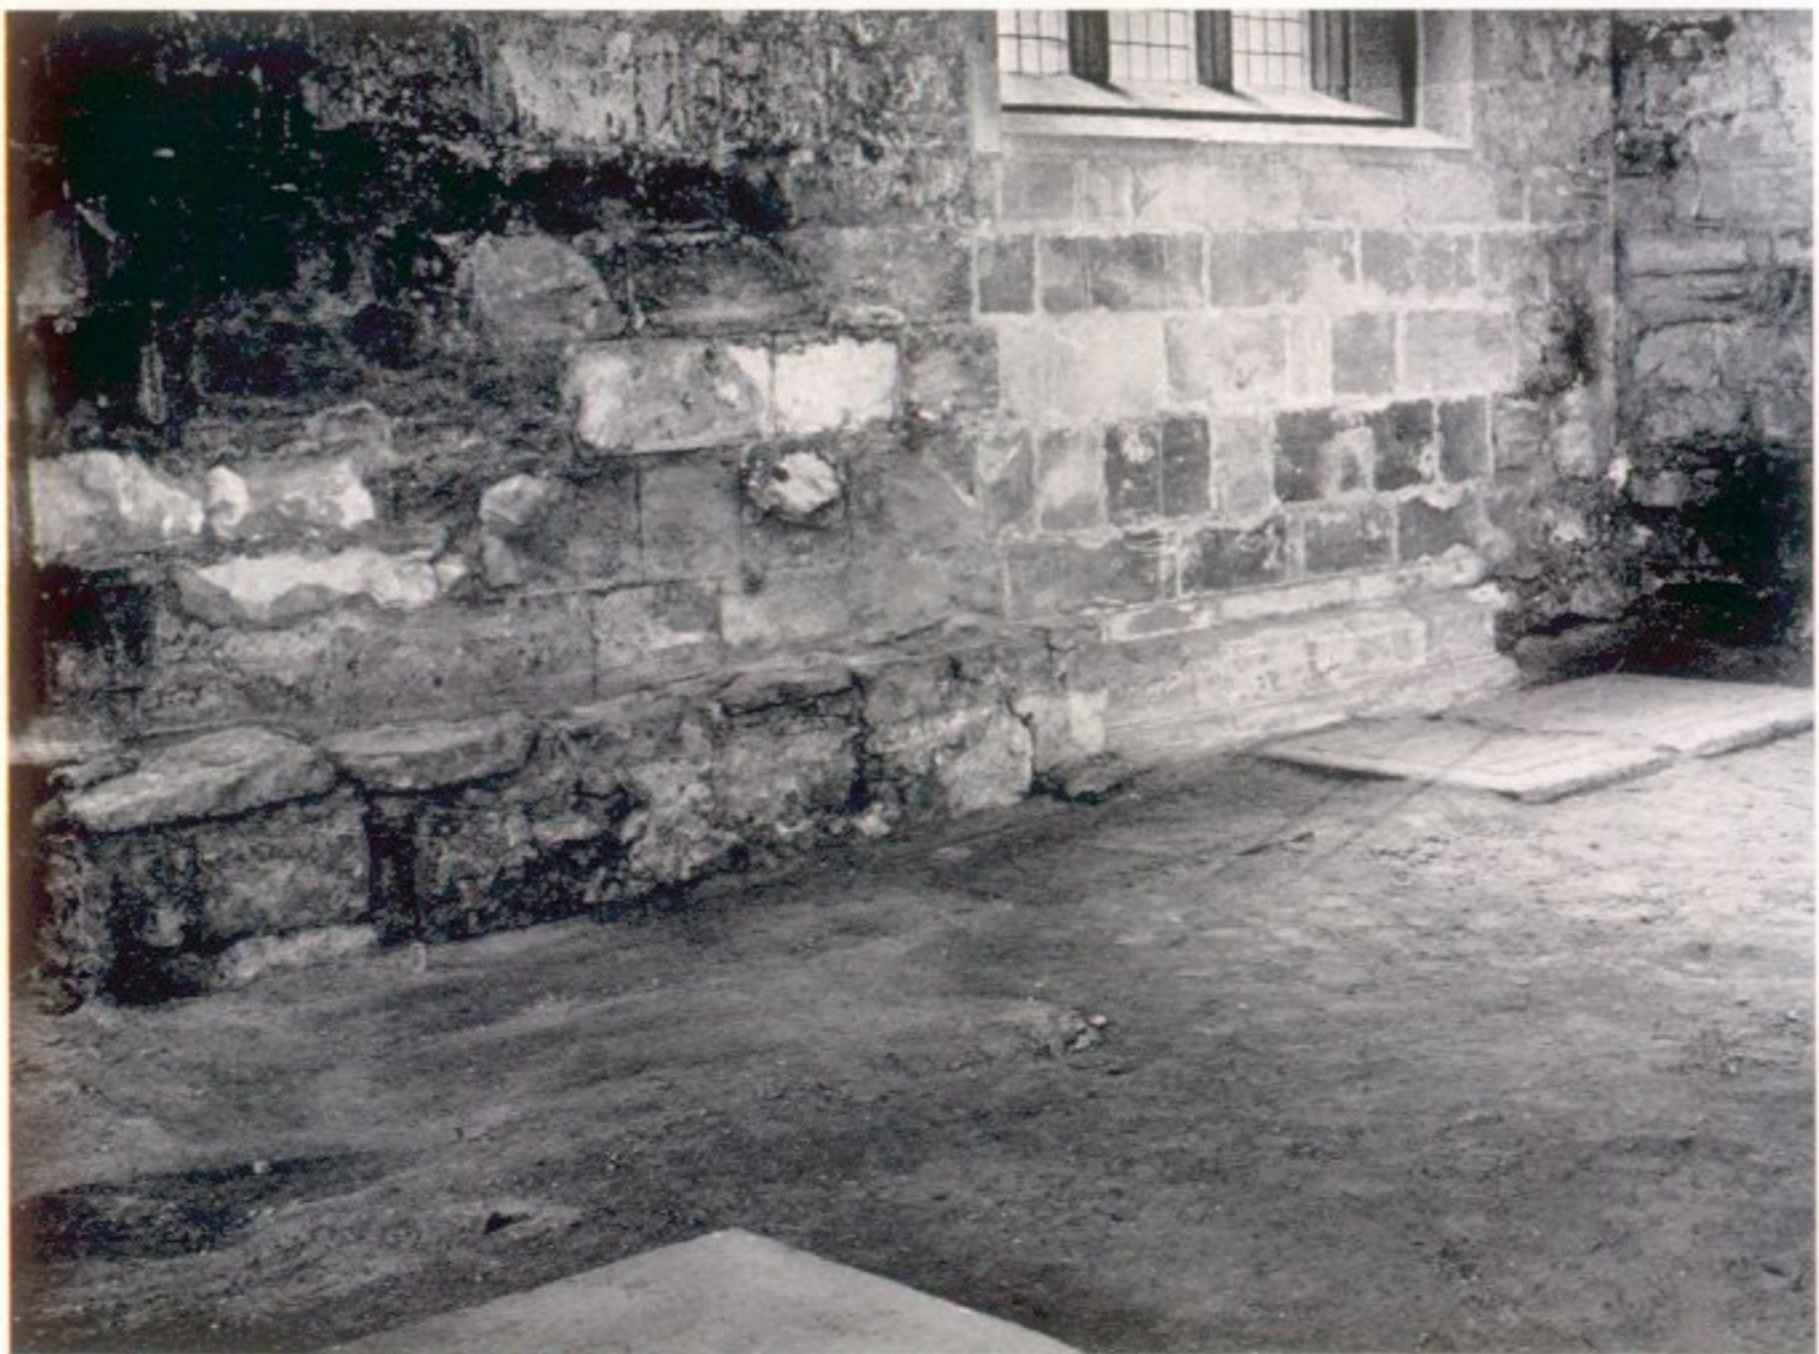
South-west corner of choir: showing lower floor, "benching," base of mural monument, rebuilt wall beneath window and gravestones.
