SETON COLLEGIATE CHURCH.

By STEWART CRUDEN, A.R.I.B.A., F.S.A., F.S.A.Scot.,  
Inspector of Ancient Monuments for Scotland.

This paper is primarily an account of work done by the Ministry of Works, and particularly a discussion of problems raised by that work.

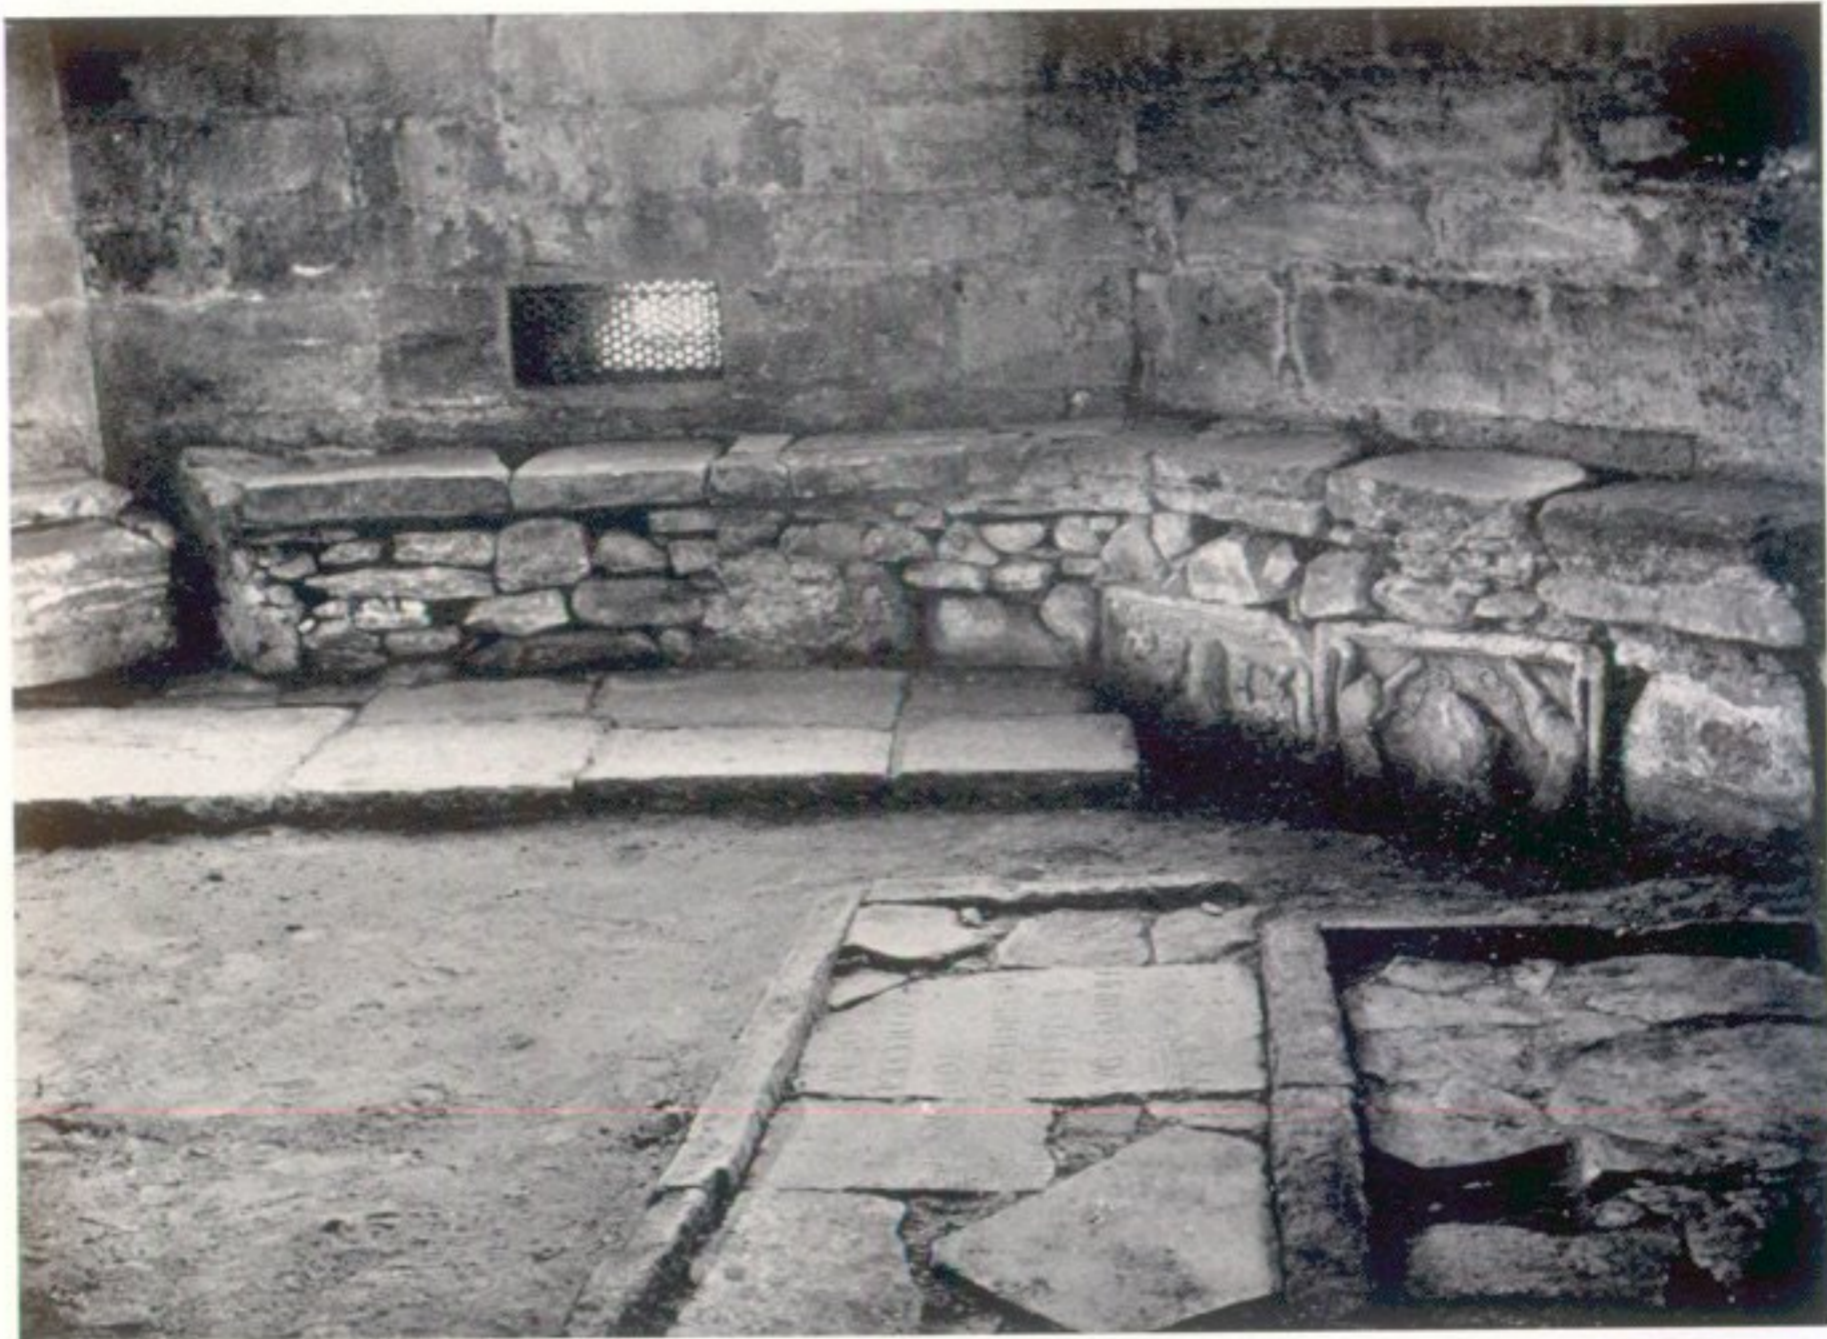
The chevet: lower floor and "benching".

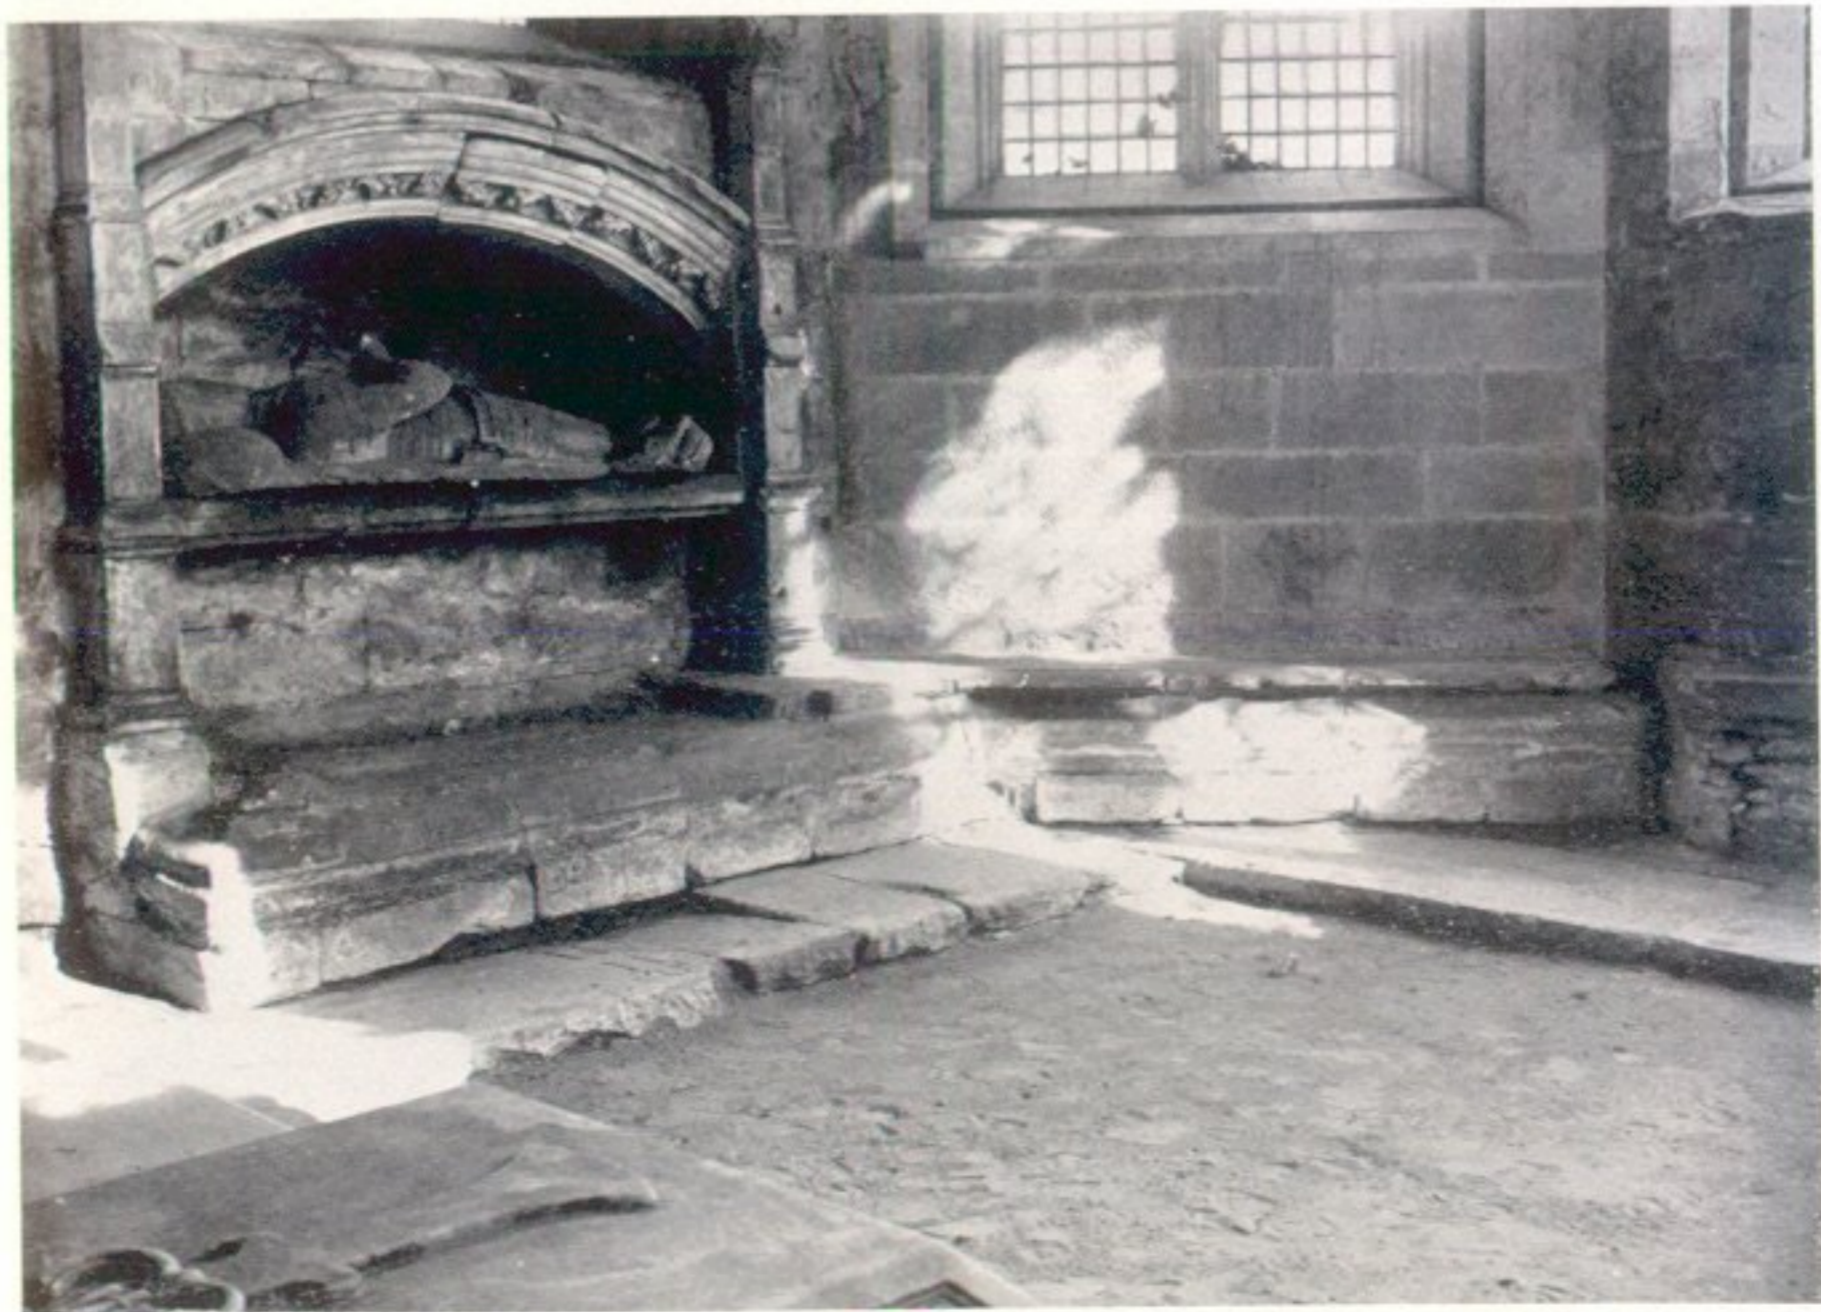
The chevet: lower floor and tomb, continuing illustration above (p. 428).
